Failure analysis of heat exchanger tubes

A. Usman, A. Nusair Khan *

Abstract

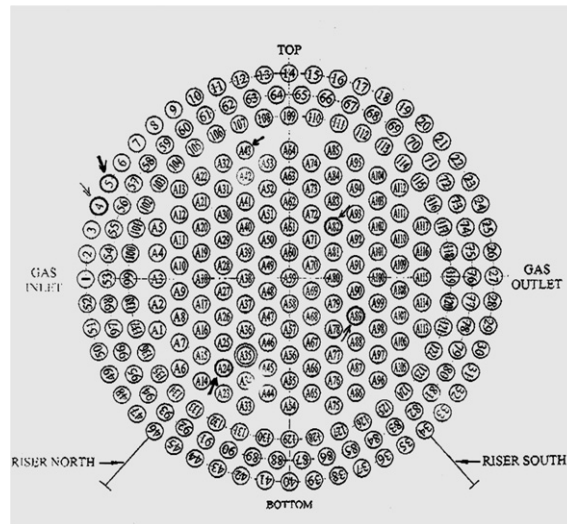
Fig. 1. Sketch showing the position of failed tubes.

The first indication of the leakage in the bundle was observed only after 20 days of its induction but the plant continued to run. After three months the plant faced emergency shut down due to sudden loss of Natural gas pressure. During this shut down the bundle of tubes was removed for inspection. Circumferential cracks were observed on five tubes, whereas three had longitudinal cracks. The location of the tubes is shown in Fig. 1. The standard tube material is 1.25Cr–0.5Mo, ASTM A213, Grade T-11.
