# Slow crack growth and failure induced by manufacturing defects in HDPE-tubes

R. Schouwenaars \*, V.H. Jacobo, E. Ramos, A. Ortiz

*Department of Mechanical Engineering, DIMEL, National Autonomous University of Mexico, Avenida Universidad 3000, Coyoacán, D.F. C.P. 04510, Mexico*

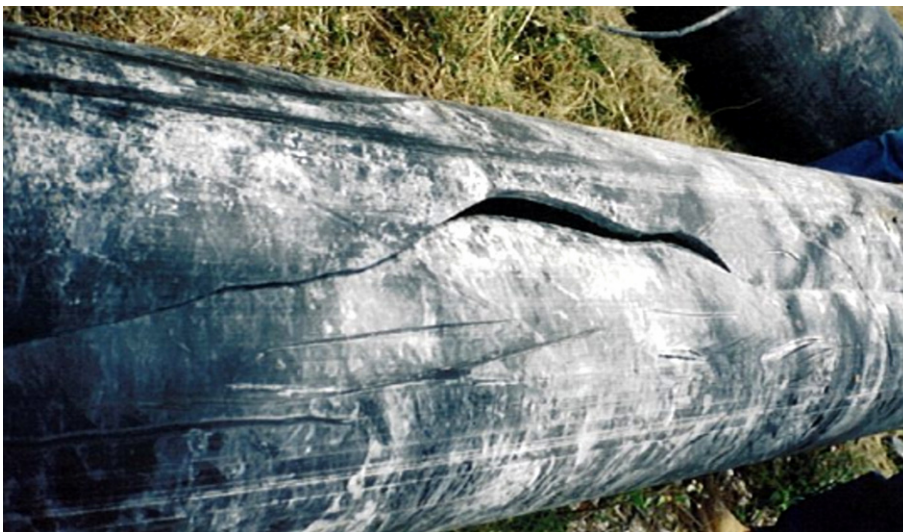
Fig. 1. Longitudinally cracked HDPE-tube.
