Investigation of a failed axle of a reduction gearbox

Wouter Ost *, Patrick De Baets, Jan Quintelier

Laboratory Soete, Ghent University, Sint-Pietersnieuwstraat 41, B-9000 Gent, Belgium

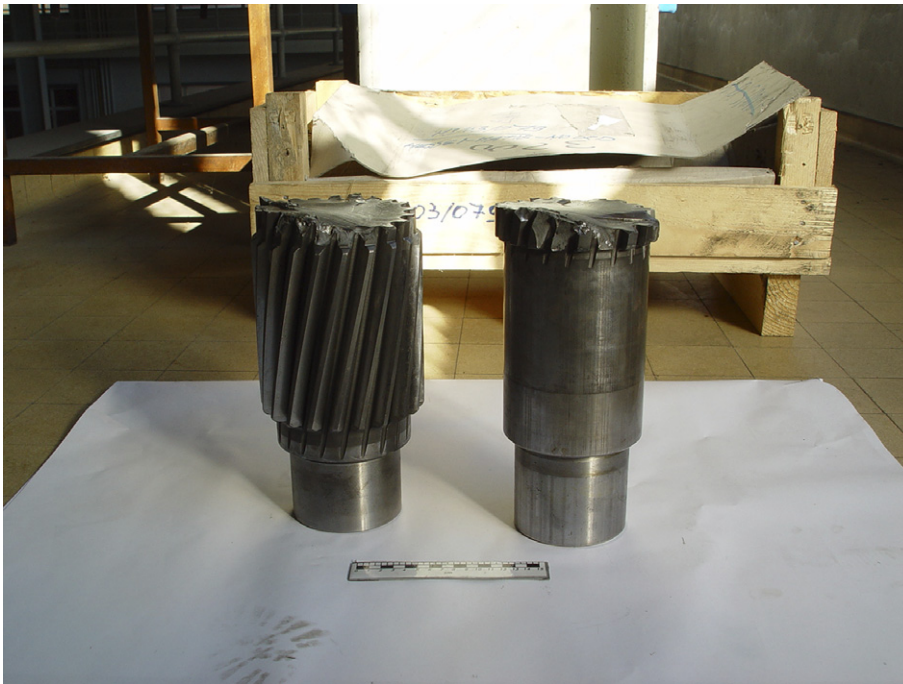
Fig. 1. View of the two parts of the failed axle.

The fractured parts of the axle are shown in Fig. 1. The gear visible on the left of Fig. 1 is an integral part of the axle and belongs to the second stage of the transmission. The teeth of this gear are case carburised. On the part shown on the right in Fig. 1 a gear of the second stage of the transmission was mounted, connected to the axle by means of a keyway (not shown in Fig. 1). Both the left and the right part of the failed axle contain a bearing seat (visible in the bottom of Fig. 1). On the left part a non-locating cylindrical roller bearing is normally mounted, while on the right part a (locating) spherical roller bearing is mounted. As shown in Fig. 1 the axle failed due to a crack in the middle between both bearings. This crack is situated on a non-contacting part of the gear machined on the axle.
