# Failure analysis of an aircraft APU exhaust duct flange due to low cycle fatigue at high temperatures

Gyu-ho Kim<sup>a,\*</sup>, Bok-won Lee<sup>b</sup>, Hongbing Lu<sup>a</sup>, Jong-hyun Park<sup>c</sup>

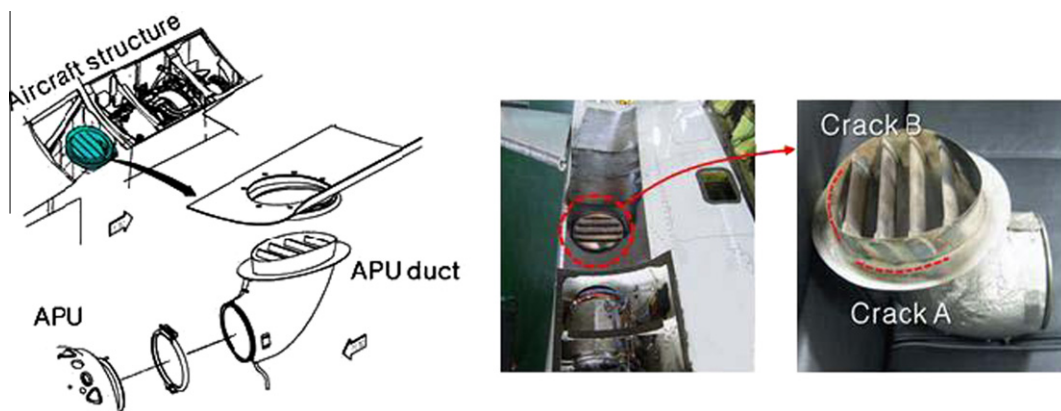
Visual observation of the crack-damaged area identified the crack length, its initiation location and propagation path as well as any surface topography features. Subsequently, that section was cut to expose the damaged surface induced by cracks. The fractograph was acquired using a Scanning-Electron Microscopy (SEM: Hitachi SU-70) with analytical energy-dispersive X-ray spectrometer (EDS) to further analyze and find the crack initiation location, its propagation pathway, damage types and/or overall failure characteristics. Thermal-stress analysis was conducted on the crack-damaged area to determine whether any environmental effects (heat) played a role. The overall features of the APU exhaust duct are shown in Fig. 1. APU exhaust duct has a flange, which was attached to the upper part of the fuselage structure. It has a circular type and includes guided outlet vanes that assist the gas to exit the aircraft. The figure shows cracks and damage in the flange.

Fig. 1. Overall features of the APU exhaust duct.
