## Last stage blades failure analysis of a 28 MW geothermal turbine

Z. Mazur\*, R. García-Illescas, J. Porcayo-Calderón

*Instituto de Investigaciones Eléctricas, Av. Reforma 113, Col. Palmira, 62490 Cuernavaca, Morelos, Mexico*

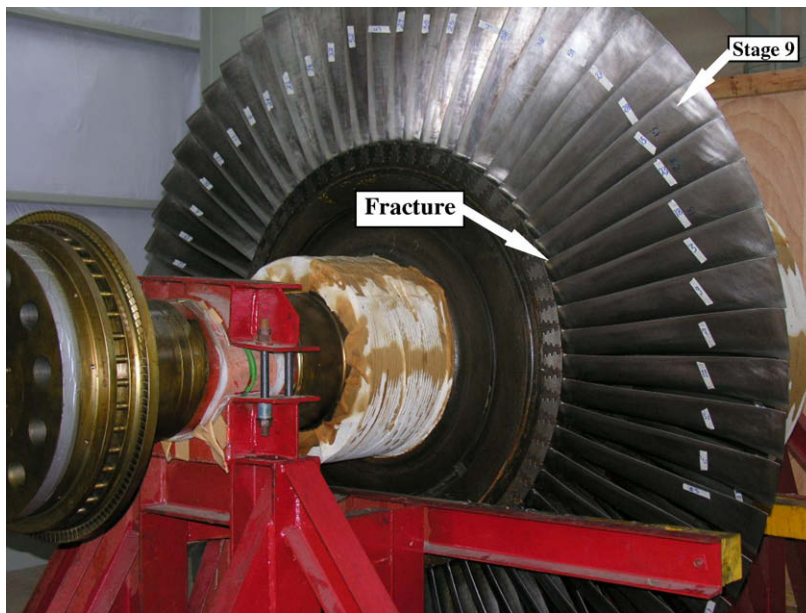
Fig. 1. General view of last stage blades (L-0) of the 28 MW unit.

row consists of 62 free-standing blades. The turbine accumulated 59,700 operation hours to failure. A general view of the last stage blades of Unit 1 is shown in Fig. 1.
