Fatigue analysis of a P180 aircraft main landing gear wheel flange

F. Bagnoli *, M. Bernabei

Centro Sperimentale Volo, Reparto Chimico, Aeroporto Pratica di Mare, 00040 Pomezia (Rome), Italy

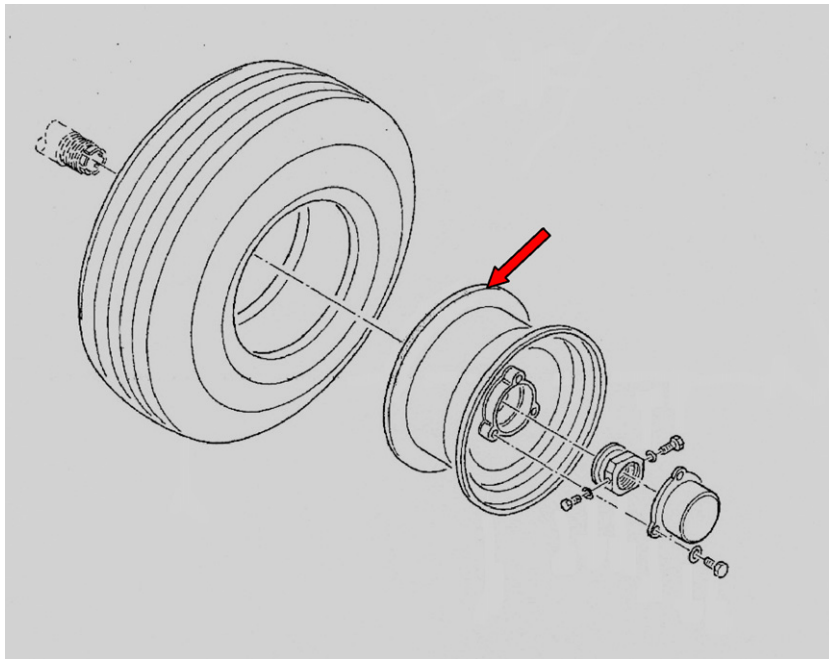
Fig. 1. Schematic view of the P-180 aircraft MLG wheel. An arrow marks the inner flange.

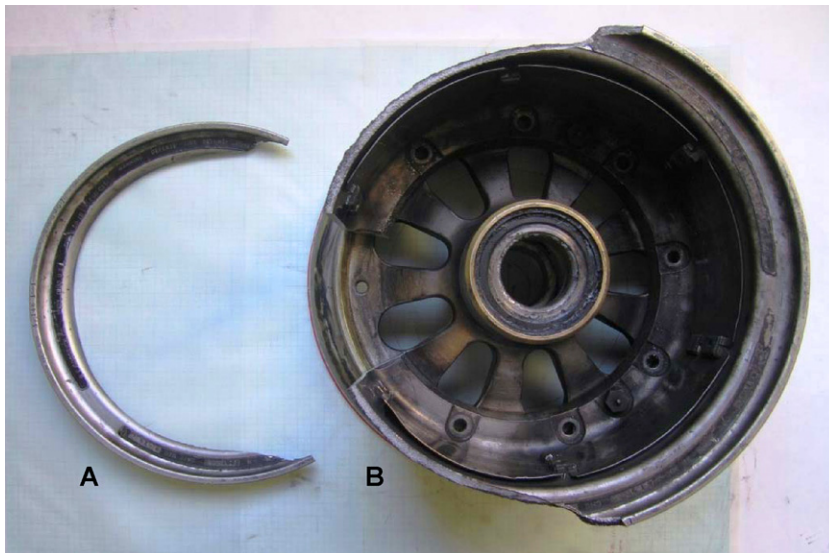
Fig. 2. General view of the failed wheel.

The results indicated the crack growth in the flange fillet was caused by fatigue. Such crack grew to approximately 8 cm in length and 5 cm in deep before the final catastrophic fracture. Multiple initiation sites due to corrosion pits existed and the largest one was measured to be approximately 315 μm deep. In particular, the
