# Fracture analysis on cage rivets of a cylindrical roller bearing

*Failure Analysis Center of AVIC, Beijing Institute of Aeronautical Materials, P.O. Box 81-4, Beijing 100095, China*

**Keywords:** Cylindrical roller bearing; Rivet; High cycle fatigue; Fretting damage

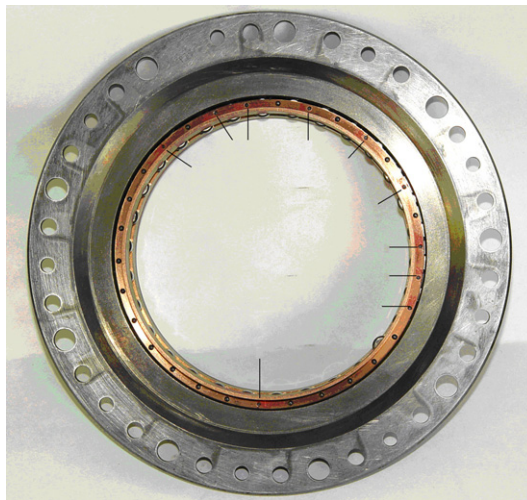
Fig. 1. Rivet distribution on the upper surface of the cage seat.

Fig. 1 shows the rivet distribution on the upper surface of the cage seat. Thirty rivets were used and ten were fractured neighboring to the cold driven head. The failed rivets are marked with solid lines in Fig. 1. Almost the failed rivets were located within the range of half circumference. The rivet bars were still kept in the mating holes. All the hot driven rivet heads were in good condition.
