Engineering Failure Analysis

Engineering Failure Analysis 15 (2008) 368-377

Cracking of the mixing chamber caused by sigma phase precipitation in austenitic steel welded joints

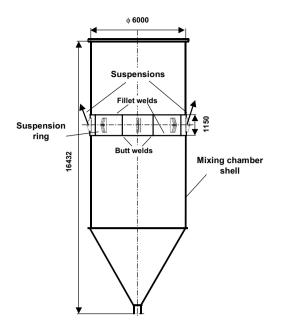
Fig. 1. Sketch of the mixing chamber.

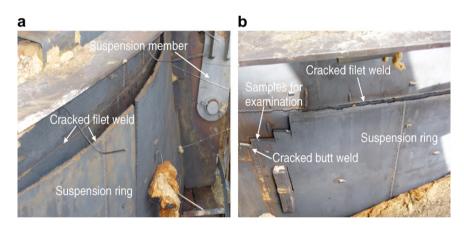
In the air mixing chamber of the chipboard production line numerous cracks have been found, which were located in the fillet welds connecting the suspension ring with the mixing chamber shell and also in the butt welds of the suspension ring (Fig. 1).

Examples of crack appearance are shown in Fig. 2.

Fig. 2. View of the cracked welded joints connecting the suspension ring with the mixing chamber shell.
