Failure analysis of a diesel engine piston-pin

Zhiwei Yu, Xiaolei Xu ^{*}, Hongxin Ding

Abstract

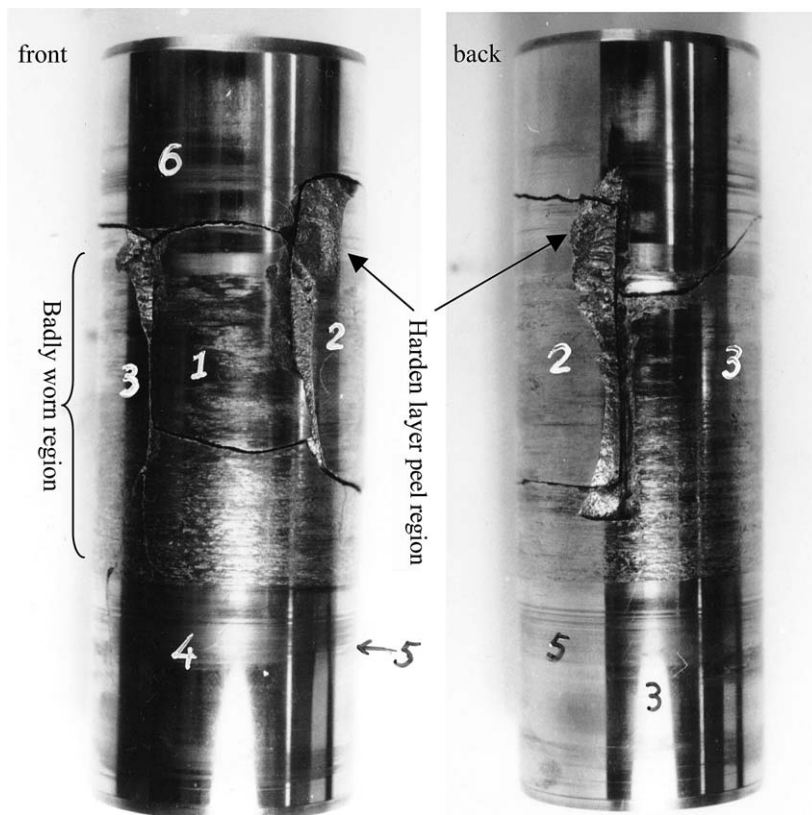
Fig. 1. Failed piston-pin.

Fragments of the failed piston-pin were put together, which are shown in Fig. 1. The failed piston-pin had fractured into four fragments (labelled 1, 2, 3, and 6) (Fig. 2) and in order to observe the fracture surface in detail, fragment 3 was open slowly along the original crack propagation direction and it separates into three parts (labelled 3, 4 and 5, seen in Figs. 1 and 2). Matched fractures are shown in Fig. 3. In order to analysis conveniently, the arc fragments of the cylindrical piston-pin are spread to make up a plane figure (Fig. 4).
