# Failure analysis of submersible pump system collapse caused by assembly bolt crack propagation by stress corrosion cracking

J.A. Escobar\*, A.F. Romero, J. Lobo-Guerrero

Department of Mechanical Engineering, Group of Materials and Manufacturing (CIPP-CIPEM), Universidad de Los Andes (UNIANDES), Cra 1 No. 18A-12, Bogota, Colombia

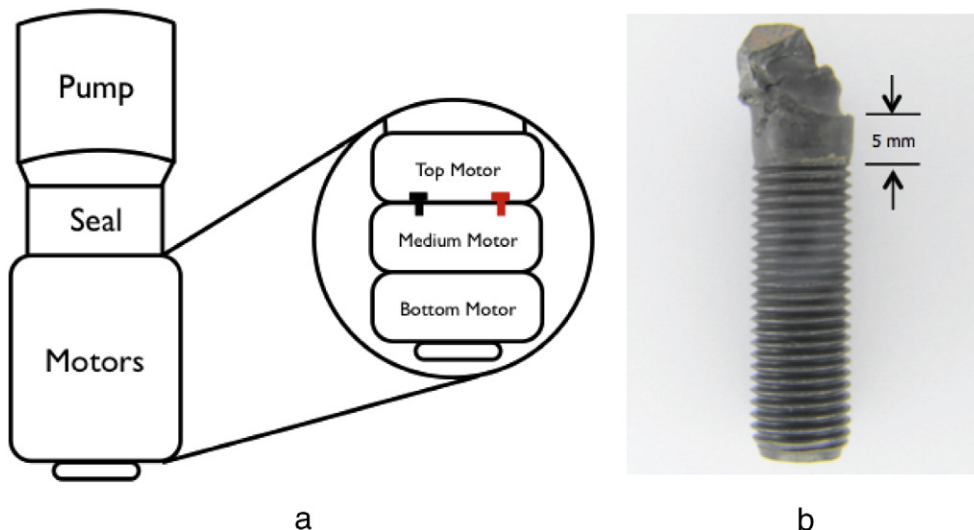
Two casing assembly bolts (Hex Head Socket Cap Screw .437-20UNF X 1.50) were received; the first one was fractured near the head, while the second one was in good condition. The material specified by the manufacturer is Monel K-500 and the dimension of the bolt follows ANSI B18.2.1 specifications as shown in Fig. 1. The function of these bolts was to connect the casings of two 390HP motors used in a submersible pump as shown in Fig. 2a.

The bolt that failed after 561 days of service and the failure location is presented in Fig. 2b. As it is seen, the bolt fractured zone is 5 mm above the thread. Working conditions for both bolts are: temperatures around 300 °C, corrosive water environment (1% petrol and 99% water), predominantly static mechanical loads resulting of the weight of the components as well as the loads produced by operation or manipulation in the well.

Fig. 2. (a) Diagram showing the location of the assembly bolts. (b) General view of the fractured bolt.
