Failure analysis of a leaching reactor made of glass-fiber reinforced plastic

Mari Lindgren ^{a,*}, Gunnar Bergman ^b, Markus Kakkonen ^c, Markus Lehtonen ^d, Jarno Jokinen ^e, Markus Wallin ^e, Olli Saarela ^e, Jyrki Vuorinen ^c

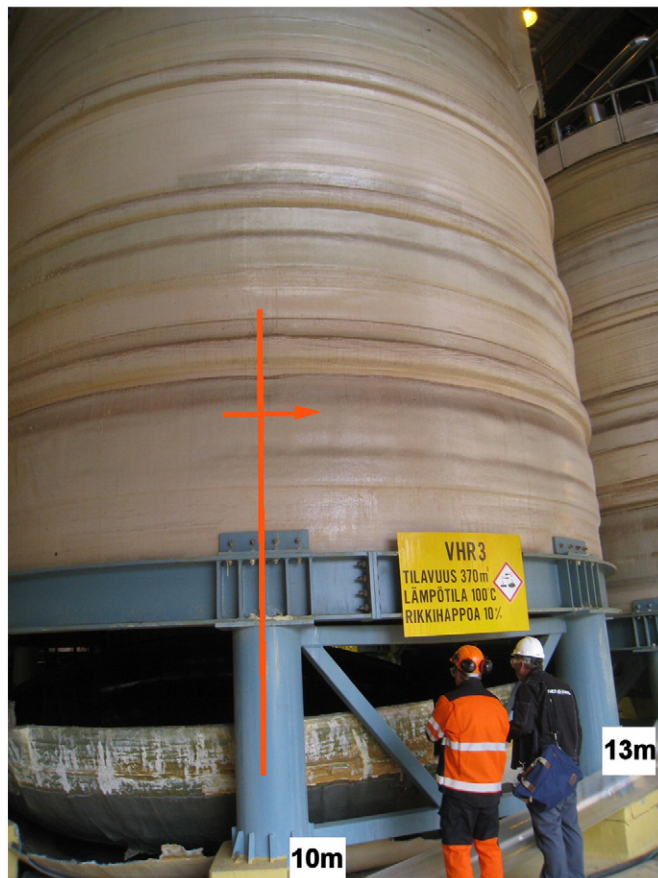
The strong acid leaching reactor, VHR3, made of fiber reinforced plastic (FRP) failed catastrophically in July 2014. After slightly less than two years of service, the bottom of VHR3 fell out during normal operation without any warning signs (see Fig. 1). This incident released the contents (370 m³) of the reactor into the surroundings in an uncontrollable manner. No human casualties occurred and the effect on the environment was minimal thanks to the safety system of the plant. There were no eye-witnesses to the incident but a loud noise was generated as the failure occurred.

Fig. 1. Overview of the failed reactor.
