## **Engineering Failure Analysis**

### On-site determination of an uncommon cracking mechanism due to composition gradients in a nickel steel weld

J. Booman<sup>a,\*</sup>, P.G. Fazzini<sup>b</sup>, José Luis Otegui<sup>c</sup>

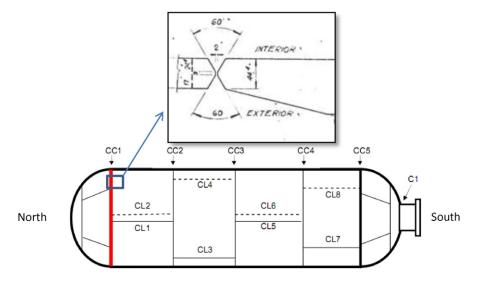
This article originates in a failure analysis of cracks found in the shell-to-cap circumferential weld of a 2440 mm diameter, 82 mm thick cryogenic vessel at a petrochemical complex, Fig. 1. All studies were performed on site, during a programmed plant stop. Two vessels with the same characteristics and operational history were operated at the facility, but only one presented discontinuities.

Fig. 1. Cracked vessel. Inset: detail of the Cap - surround welded joint.

There are no records of inspections since reception up until 2010, since the vessel had been classified as of low risk. In 2010 nondestructive testing (NDT) was performed, and cracks were detected in one of the cap to shell circumferential welds. These cracks were small and mainly in the direction of the weld, i.e. circumferential to the vessel, and were repaired by grinding. During inspection carried out two years later, cracks were found again, this time spread in different directions [3].
