Analysis of catastrophic failure of axial fan blades exposed to high relative humidity and saline environment

Javier A. Vargas, José E. Wilches, Humberto A. Gómez, Jovanny A. Pacheco, Roque J. Hernandez*

Department of Mechanical Engineering, Materials, Processes and Design Research Group, Universidad del Norte, Barranquilla, Colombia

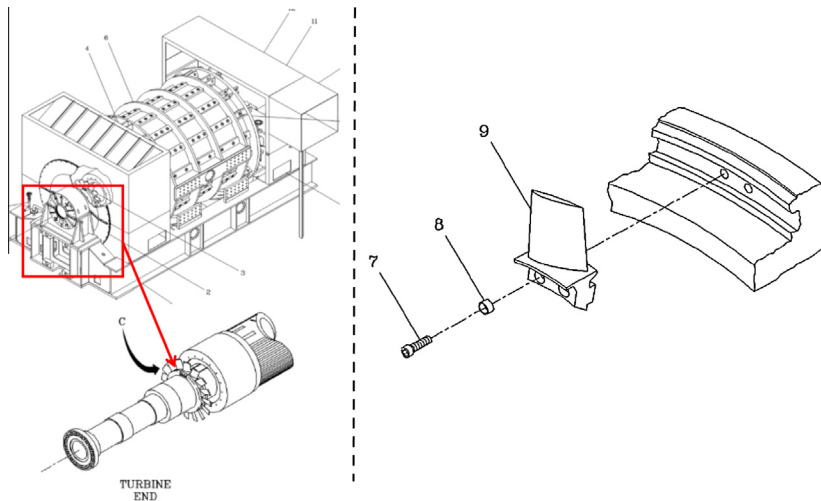
Fig. 1. Blower generator rotor and broken blade scheme with the security hardware.

Fig. 1 shows the fan installation with the blower of the generator rotor and a scheme of the broken blade. The failure was detected in of one of the 24 blades located in section C; all blades are identical as element 9 of the scheme.
