Corrosion–erosion wear of refractory bricks in glass furnaces

A.M. Guzmán^{a,*}, D.I. Martínez^a, R. González^b

This paper presents the failure analysis of alumina–zirconia–silica (AZS) refractory bricks located in the glass level in the tank of a furnace for melting glass, since is the region where there is greater wear respect to the base. The wear of the refractory was evaluated after 4 years of campaigning, under thermal and mechanical loading during the glass manufacture. The analysis by scanning electron microscopy shows high porosity and the presence of alkalis is also detected from the glass composition, being the phase alumina–zirconia–silica (AZS), the one that shows better resistance to erosion wear by displacement of the molten glass. The analysis yielded the following mechanisms of chemical wear, removal of the vitreous phase toward the surface of the sample due to the increase in temperature of the furnace, and therefore attack by vapors through the porosity caused by the exudation of the vitreous phase, as well as deterioration of the microstructure of the refractory due to the formation of cracks. Because it is considered as the main problem in these types of furn

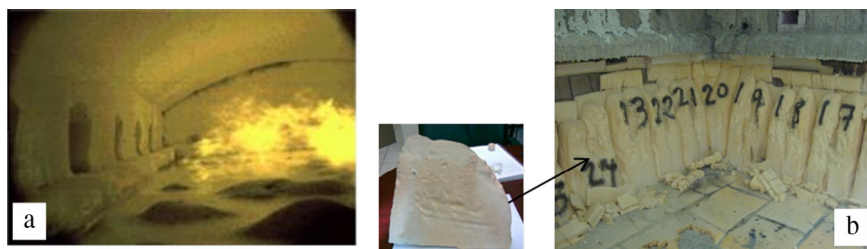
Fig. 1. (a) Glass furnace, during melting process. (b) Brick sample extracted from the furnace (glass flow zone).

The evaluation was made in new AZS refractory bricks and AZS bricks extracted from a furnace after 4 years campaigning, Fig. 1a shows a furnace in use during the glass melting process, and the 1b indicates the placement of the samples took for this research.

Surface images were taken using a stereographic microscope to determine the wear, hot face exposed to fluid (see Fig. 1b). Coupons of 5 by 5 cm² were cut from the surface and the images were taken at a 50× magnification, observing cavities and deformation of the material in the liquid glass flow direction, the volume wear was determined through image analysis of the attacked zone, calculating the average loss of wall thickness on each section, once wear was determined in the samples, a correlation between the final microstructure and mechanical properties of the refractory was made.

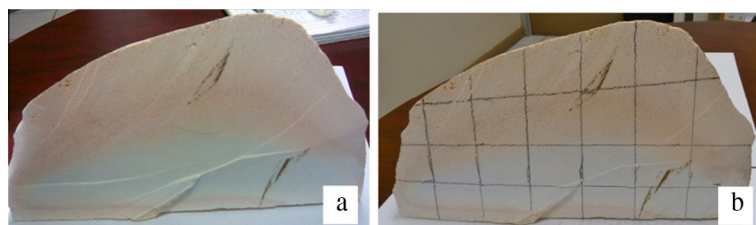
Fig. 2. (a) Transversal cut of the brick and (b) samples analyzed.

In samples from areas where attack occurs (Fig. 2a) microstructural observations were made, through light and electron microscope (JEOL-SEMJSJSM-6510LV) with semi quantitative EDS (energy dispersive spectrometry) phase analysis. Subsequently, cubic cuts were performed to determine physical and mechanical properties of the refractory according to the penetration profile of molten glass (Fig. 2b)
