# Failure of a pressure vessel for rail transport of fluid carbon dioxide

R. Häcker

BAM Federal Institute of Materials Research and Testing, D-12200 Berlin, Germany

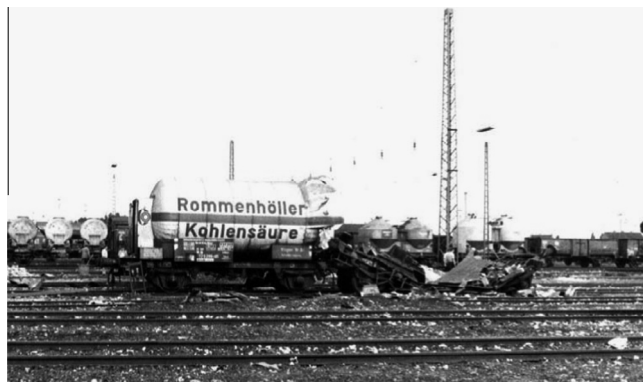
In 1976, a pressure vessel of a tank wagon burst during gravity shunting at the gravity shunting yard in Haltern, Northern Germany. Two coupled tank wagons, both containing pressure vessels filled with liquefied carbon dioxide, were not correctly braked and as a result rolled downhill too quickly onto two rail brakes that were positioned on the track by shunt operators. The first rail brake was ejected and the other one caused impulsive vibrations in the pressure vessels as it failed to arrest the wagons. The pressure vessel of the leading wagon failed explosively. The leading tank wagon was fully destroyed, and the second tank wagon of identical construction was damaged but the filled pressure vessel stayed intact (see Fig. 1).

Fig. 1. Exploded tank wagon beside an identical tank wagon with damaged isolation cover.

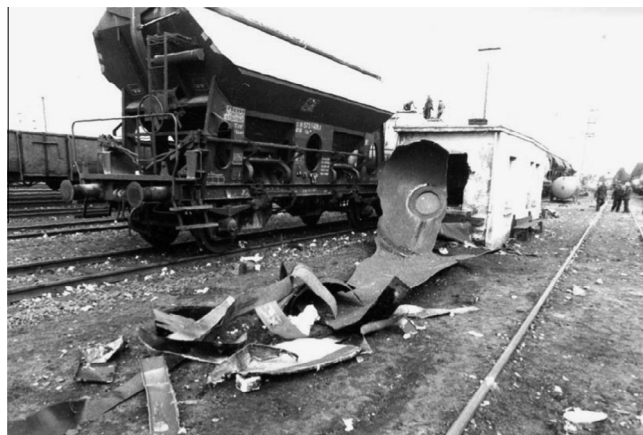
Large pieces of the vessel were flung up to 300 m, resulting in damage to a building for railway staff (see Fig. 2), and the death of one shunt operator. Further wagons, tracks, and the superstructure of the gravity shunting yard were damaged.

Fig. 2. Vessel remnants, including a large piece that impacted a building used by railway staff.
