Investigations on the breakdown of a heat recovery steam generator during the initial operation run

D. Bettge*, C. Klinger, D. Klingbeil, A. Eberle

Federal Institute of Materials Research and Testing (BAM), Berlin, Germany

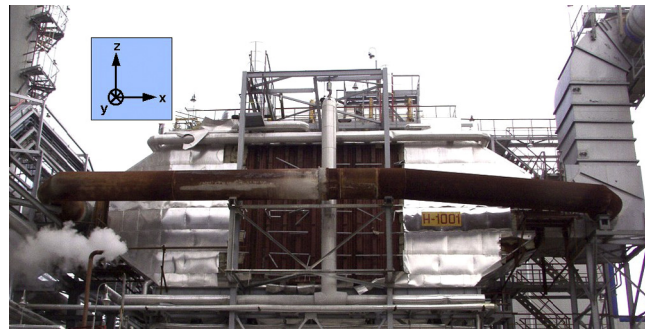
Fig. 1. Installation situation of the steam generator at a chemical plant, side view with temporary bypass tube. Coordinate "x" indicates the direction of airflow.

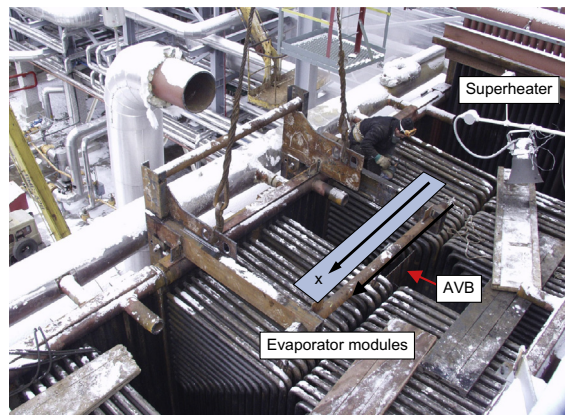
Fig. 2. Dismantling of the heat exchanger at the chemical plant. Top view of the evaporator. Arrow points to an anti-vibration plate (AVB). Coordinate "x" indicates the direction of airflow.

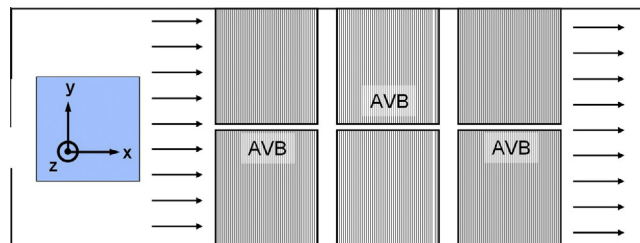
Fig. 3. Sketch of the positions of the six evaporator modules in the heat exchanger box, top view, compare Fig. 2. Arrows mark the exhaust air stream. "AVB" marks the positions of anti-vibration plates.
