## Failure analysis of a hydraulic Kaplan turbine shaft

This paper shows the results of the failure analysis of a 105 MW Kaplan turbine auxiliary shaft from a hydropower plant. As a part of the failure analysis, the turbine operation history was revised and the metallographic study was done. A sample of the cracked turbine shaft was examined using optical microscopy and scanning electron microscopy. Failed auxiliary shaft was coupled to the main turbine shaft and its principal function was turning the runner blades according to flow direction. In order to complement the cause of failure, a finite element analysis (FEA) was done to calculate the stress level under the maximum and minimum turbine blade inclination position. The results of present investigation showed that failure was caused by high cycle and low stress fatigue. The presence of a stress concentrator on the turbine shaft was a crucial factor to the fatigue crack-initiation phase. The FEA revealed also that the frequently load variations, showed in the operation history, could have contributed to the crack propagation.

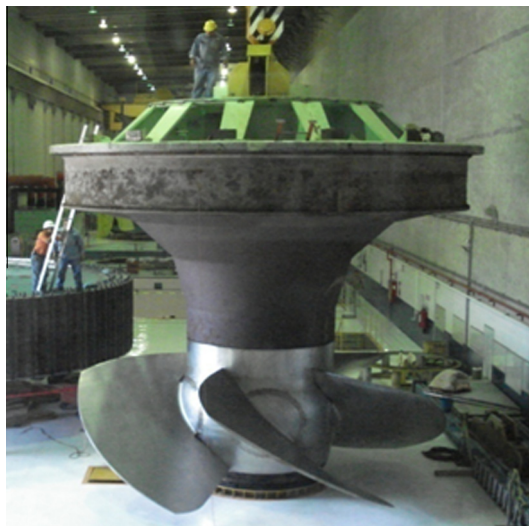
Fig. 1. Kaplan turbine runner.

Principal shaft of the 105 MW Kaplan hydraulic turbine is shown in Fig. 1, has 10.3 m of length, 1.1 m of diameter and 101,000 kg (runner included), runner has 6.60 m of diameter and five blades.
