Site investigation of damages occurred in a steel space truss roof structure due to ponding

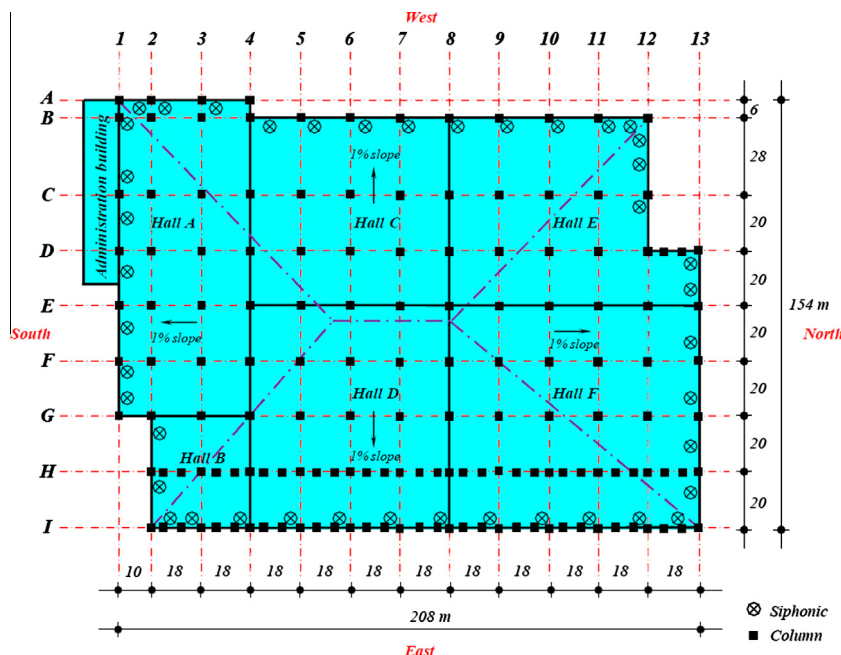
As can be seen in Fig. 1, Hall A covered 5244 m² area in the south-west region of the industrial building between the A–G and 1–4 axes in plan view. 4567 steel pipe members were used in the space truss roof system which was supported on 28 reinforced concrete columns with different spacings. Hall B in the south-east region covered 1440 m² area between the G–I

Fig. 1. Scheme of the industrial structure subjected to ponding due to heavy rainfall.
