Failure analysis of a martensitic stainless steel (CA-15M) roll manufactured by centrifugal casting. Part I: Material and fractographic characterization

Cesar R.F. Azevedo*, Rafael R. Maia, Edwan A. Ariza, André P. Tschiptschin

Department of Metallurgical and Materials Engineering, Av. Professor Mello Moraes, 2463 - 05508-030 São Paulo, SP, Brazil

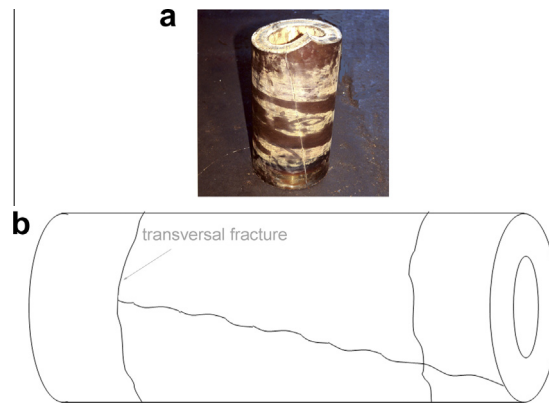
A hollow roll used as a glass roller, made of centrifugally cast CA-15M martensitic stainless steel, broke just after six rolling campaigns (three of them with 48 h of operation each). According to available information the roll finally “fractured” half an hour after withdrawing from the production line at the end of sixth campaign, during cooling in still air. The cylinder was 800 mm in length, had an external diameter of 265 mm and an internal diameter of 165 mm, with a wall thickness of 50 mm. The roll was “internally and externally machined and submitted to a stress relieve heat treatment, before being chromium plated and mounted in the glass rolling equipment”. The roll works in contact with molten glass at a temperature of 1100 °C and its outer surface should not exceed temperatures between 425 and 475 °C. During the glass rolling operation, the roll is cooled internally by water circulation. Within the cylinder, an aluminium core supports wood fins, whose function is to separate three different cooling zones, in which water flow can be regulated to minimize roll distortions. Also, according to information, the inner walls of the cylinders are lined with hard chromium to avoid the formation of deposits, which may reduce the cooling efficiency of the roll. According to the staff of the factory, they first identified longitudinal crack near one end of the cylinder and 15 min later two transversal cracks in regions located about 70–80% from the roll centre to its ends (see Figs. 1 and 2).

Fig. 1. (a) General view of the transversal fracture of the cylinder with the presence of a secondary longitudinal crack. (b) Scheme showing the position of the transversal and longitudinal cracks in relation to the length of the roll.

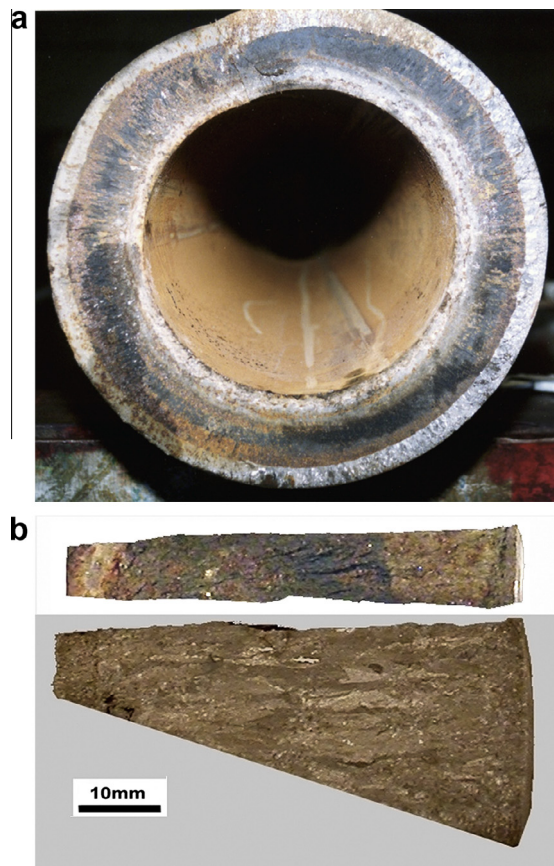
Fig. 2. (a) General view of the transversal fracture surface of the cylinder with the presence of three regions, which are roughly related to the macrostructure of the cylinder. (b) Transversal cross section, macrographic examination, shows the macrostructure evolution (after etching) during the solidification from the external surface (left) featuring chilled region (left), columnar region (centre) and equiaxed region (right) and its relationship with an old piece of the fracture surface.
