Investigation of failure and damages on a continuous casting copper mould

Silvia Barella*, Andrea Gruttadauria, Carlo Mapelli, Davide Mombelli

Politecnico di Milano, Dipartimento di Meccanica, Via La Masa 1, 20156 Milano, Italy

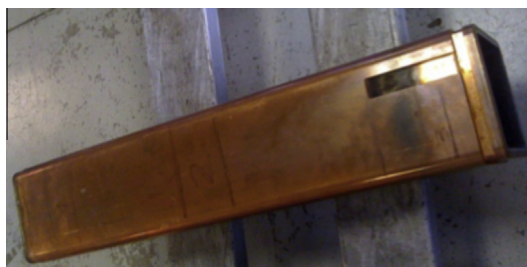
This paper presents the failure analysis of a copper-based mould whose sides are coated with chromium. The performed analysis points out that the extended damage is due to two main causes: the failure origin is attributed to thermal stresses caused by working conditions and the copper wear is associated with the high zinc content of the liquid steel.

Fig. 2 shows the mould under investigation. The working mould face had considerable damage in the meniscus region. After an extensive visual examination, the mould was cut into different samples in order to carry out SEM (scanning electron microscope) examination of the damaged surface. The SEM was equipped with an EDS (energy dispersive spectroscopy) probe that was used to perform local chemical analyses. Metallographic analyses were performed to characterize the mould microstructure. These analyses were realized by optical microscopy and SEM. All of the samples were prepared by grinding and polishing. Micro-etching was performed by means of an HCl solution (50 ml HCl, 5 g FeCl_3 , 100 ml water) applied for 10 s [11]. Micro-hardness Vickers tests were performed with a 300 g load and an indentation time of 15 s.

The examined mould showed significant damage approximately 110 mm from the mould top, at the meniscus level. This damage was even detectable from the external mould side, where the copper mould assumed a colour typical of high

Fig. 2. Failed square mould.
