Failure analysis on fracture of worm gear connecting bolts

Ling Li*, Rong Wang

Shanghai Key Laboratory of Engineering Materials Application and Evaluation, Shanghai Research Institute of Materials, Shanghai 200437, China

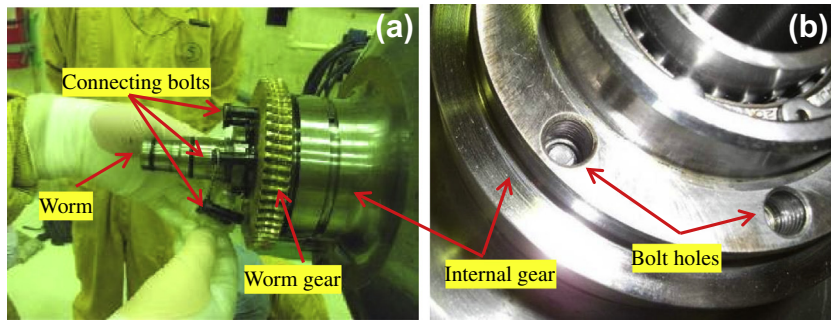
Fig. 1. Failure scene of the fractured worm gear connecting bolts (a) before dismantling and (b) after dismantling.

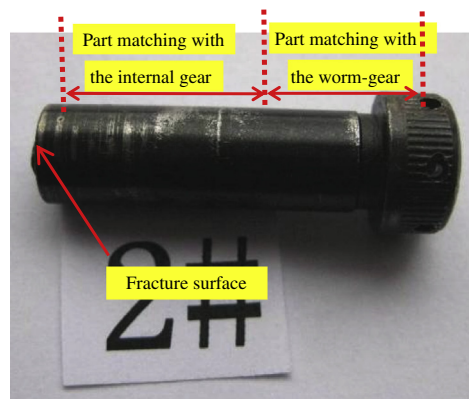
Fig. 2 is one part of the fractured connecting bolt. It can be seen that the bolt fractured at the transition arc position near the bolt thread neck, with the fracture surface being approximately perpendicular to the bolt axial direction. The bolt surface was covered with black oxide film except the part close to the fracture surface, where the black oxide film was damaged and distributed in equidistant parallel just like the screw threads, and it is considered the result of repeated contact between the bolt and the bolt hole of the internal gear.

Fig. 2. Macro morphology of one part of the fractured bolt.
