Failure of a crankshaft of an aeroengine: A contribution for an accident investigation

The objective of this work is to determine the main cause of failure of a crankshaft from an ULM airplane aeroengine. The core of this paper is focused in the analysis of the damage mechanisms which were in the base of a catastrophic failure of the crankpin journal. Based on a preliminary observation of the fracture surface, there are clear evidences of a fatigue process as both beach and striation marks have been identified. The judicious characterization of the failing mechanism, including the identification of the crack initiation site and the assessment of the crack propagation rate, is of paramount importance to support the investigation of this aircraft accident. In this context, an exhaustive observation of the fracture surface by means of optical and electronic microscopic techniques, in parallel with microstructural examinations, were carried out as determinant information for the correct assessment of the contributive causes to this accident.

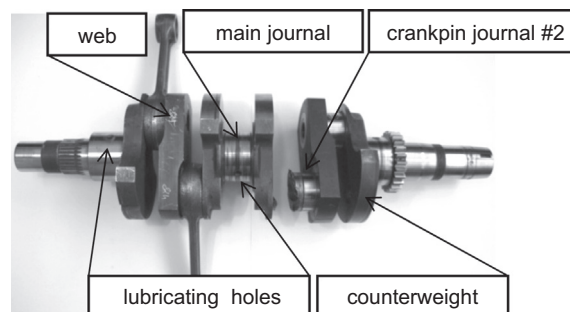
The failed crankshaft presented in this work belongs to a four stroke, four cylinder liquid air cooled engine of an ultralight airplane that had an accident. The nominal power output of this engine is 73.5 kW at 5800 rpm. At the time of the accident, the engine had a total of 996 h of reported service. According to the technical specifications provided by the manufacturer, this engine's TBO (Time Between Overhauls) is 2000 h. The failed component is depicted in Fig. 1 where it is possible to visualize the fracture zone in the interface between the crankpin journal #2 and the counterweight. Each of the crankpin journals has been press-fit into the web sections in the opposite end to the counterweight.

Fig. 1. Image of the failed crankshaft. Fracture has occurred in crankpin #2.
