# Engineering Failure Analysis

## Investigation of a Boeing 747 wing main landing gear trunnion failure

S.A. Barter\*

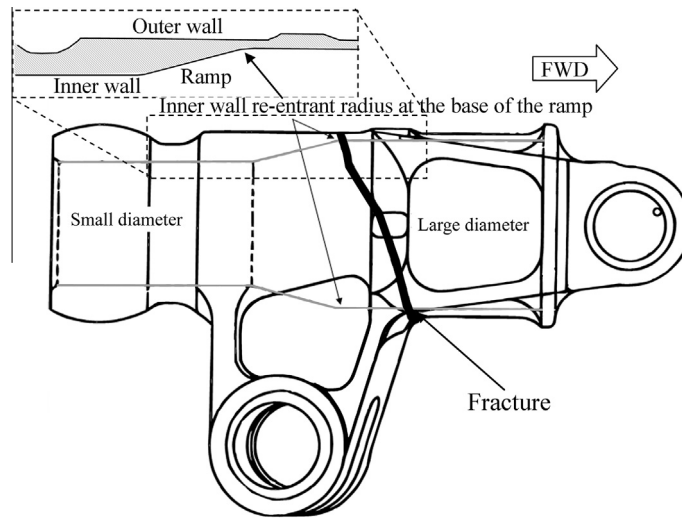
**Fig. 1.** A schematic of the part is shown, with the internal bore marked by the grey lines and a thick black line indicating the approximate path of the failure. An expanded view of a section of the wall is shown in the dashed box. This indicates several features of interest noted in the investigation.

The failure occurred about halfway along the trunnion, severing the entire cross-section. Fig. 1 shows that the failure was between the drag brace attachment lugs and the fork end. Fig. 2 shows the two parts of the trunnion after fracture. The fracture is clearly seen to run through the entire cross-section of the tube at about the middle of the component. The circles in Fig. 2 encompass an area of the fracture that was corroded and appeared to be significantly older than the rest of the fracture.
