Engineering Failure Analysis

Failure analysis of an aircraft engine cylinder head

The piston engine of the training aircraft malfunctioned during the flight due to the cracking of its cylinder head (CH), which is manufactured from an aluminum casting alloy. Based on the fractographic examination of the mating fracture surfaces, the characteristic ratchet and beach marks were observed indicating the occurrence of fatigue failure. The crack was initiated from multiple origins located on the inner flange fillet on the exhaust side of the CH. The metallography examination has shown that the fatigue was promoted from pre-existing material defect due to an elevated presence of shrinkage pores at the crack initiation zone and was most likely associated with the manufacturing process of casting. The finite element (FE) method, utilized to determine the stress state of the CH subjected to gas pressure, also confirmed that the crack origin was located at the most stress area.

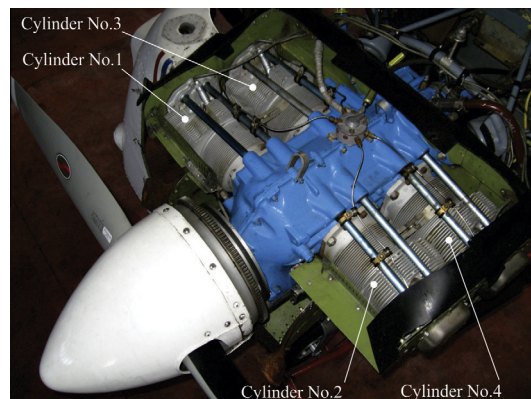
Damaged cylinder from Utva-75 had been installed on the engine in the number one position (Fig. 2). By the time of the occurrence flight, it had accumulated 1560 flight hours since new and 360 h since overhaul. The recommended time between overhauls for this type of engine is 2000 h. The last periodic (50 h) compression test was conducted at 1545 h of total flight time or 15 h before accident. The result of differential pressure test is presented in Table 1.

Fig. 2. Utva-75 engine.
