Engineering Failure Analysis

High temperature failure of natural gas feed burner pipe

S. Kaewkumsai*, W. Khonraeng, N. Sathirachinda

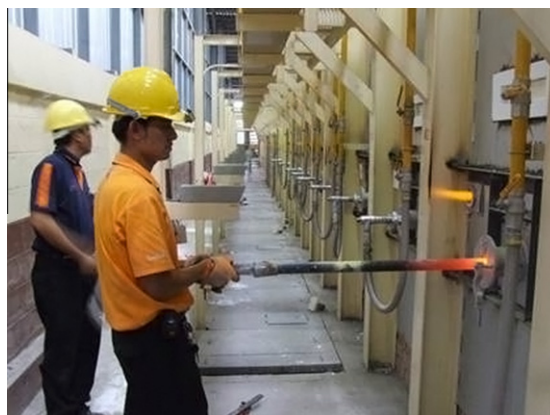
During on-site investigation, the end of the pipe was observed during operation as orange-yellow in color as shown in Fig. 1. It is consistent with a pipe that has been used above normal operating temperature (1173 K). After taking out the pipe from the furnace and immediately measured the temperature, it was found that the temperature of the outer surface of the pipe is in the range of 1323–1373 K, which is higher than the designed value (1173 K). The temperature inside the furnace monitored using an infrared pyrometer was 2003 K. After sampling the specimens for laboratory testing, the degraded pipe (Fig. 2a) was visually examined. Severe degradation was mostly found on the inner surface of the tip portion. This indicated that pipe was exposed to severe carburising environment. Formation of blackish-gray scale with a thickness of about 0.4–0.5 mm and separation of the scale from the base material were observed (Fig. 2b). Careful examination of the spalling scale revealed the characteristics of deposited carbon or coke and metal particles. Material cracking and bulging were not noticed.

Fig. 1. The appearance of pipe during operation.
