Failure analysis and safety evaluation of buried pipeline due to deflection of landslide process

J.Y. Zheng, B.J. Zhang, P.F. Liu*, L.L. Wu

Institute of Process Equipment, Zhejiang University, Hangzhou 310027, China

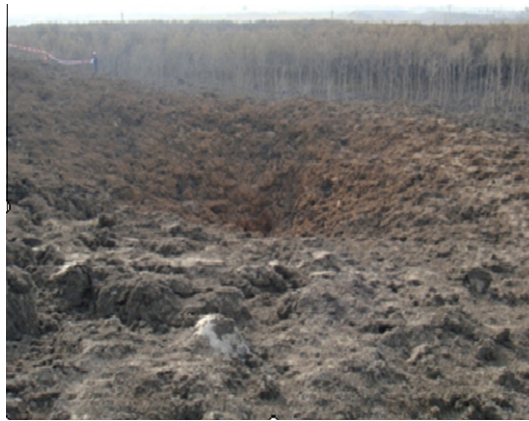
Fig. 1. Pipeline accident in Ningbo city of China.

In 2008–2009, two typical accidents of buried pipeline caused by landslide appeared in Zhejiang province of China. The earlier accident happened in Yuyao city, where the maximum deflection displacement reached about 1.9 m [15]. Fortunately, the offset segment of pipeline was detected timely and replaced before leaking. The latter accident occurred in Ningbo city as shown in Fig. 1. Terribly, the pipeline exploded at last. The site inspection indicated that the accumulated soil was deposited on the hillside, and the pipeline segment and its surrounding soil were severely pushed away from the original location during landslide process in rainstorm days.

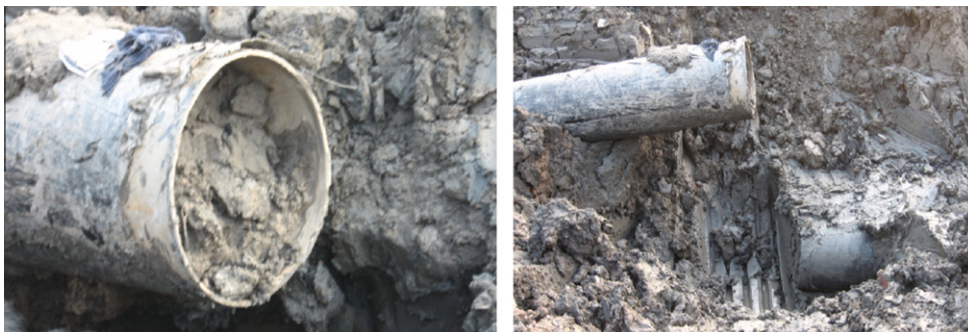
Caption near the fracture location is shown in Fig. 2. As indicated in the picture, the pipeline is ruptured circumferentially in the butt-welded joint. The outer diameter of the fracture surface is 813.6–814.3 mm, which is close to the original value.

Fig. 2. Captions near the fracture location of accident pipeline.
