Broken metal fingers in silicon wafer solar cells and PV modules

Pooja Chaturvedi *, Bram Hoex, Timothy M. Walsh

Solar Energy Research Institute of Singapore, National University of Singapore, Singapore

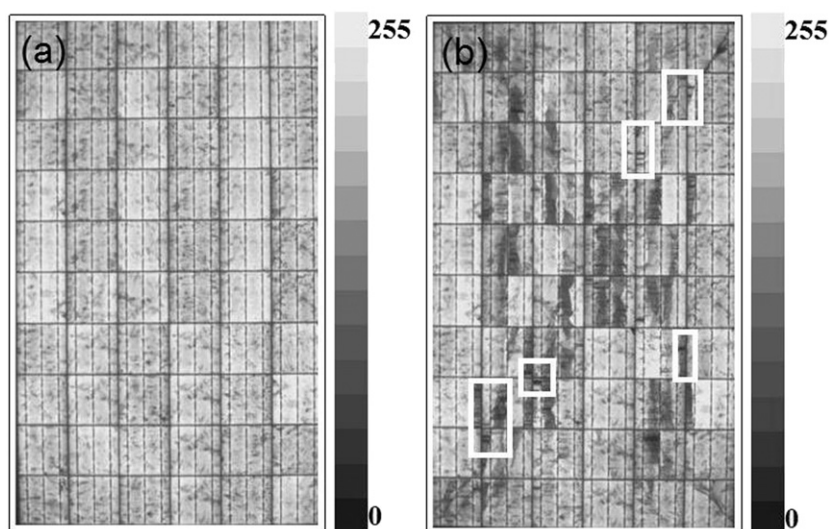
The initial EL image in Fig. 1(a) shows a relatively uniform EL intensity from the PV module. However, after the mechanical load test (with 2400 Pa uniform load) many cells in the module have a lower EL intensity compared to the image taken prior to the test, even though an identical forward bias current was flowing through

each solar cell. This is illustrated in Fig. 1(b). The EL signal is determined by the separation of the electron and hole quasi Fermi levels, the internal voltage, at that point [10]. A higher relative EL intensity implies a higher internal voltage, and vice versa. The internal voltage at a specific point can be low due to the low quality of the diode or due to a local high series resistance at that point in the PV module (e.g. caused by broken contact fingers).

In Fig. 1(b) two different types of dark regions are observed in the EL image of the module after mechanical load testing. The first type of dark regions are irregularly shaped (for example in the upper left and upper right cells in the picture). These dark regions are due to cracks in the silicon wafer solar cells. The second type of dark regions are rectangular (or square) in shape (highlighted by the white rectangles in the picture), and extend from one of the busbars of the cells. It is hypothesised that these rectangular dark regions are due to metal fingers which are broken at the busbar.

As seen from Table 1, the maximum output power (P_{mpp}) and fill factor (FF) of the module after mechanical load test decreased by 3.6% and 3.0% respectively, while the open-circuit voltage (V_{oc}) and the I_{sc} largely remain unaffected in this experiment. Hence this module still passes this IEC test, as the power reduction is less than 5%. However, the EL image clearly detects severe damage of the module after the mechanical load test that potentially results in a failure if the module is, for example, subsequently exposed to thermal cycling.

Fig. 1. Electroluminescence images of a silicon wafer based PV module (a) before and (b) after a uniform 2400 Pa load mechanical load test. Many dark areas are present in the EL image of the module after mechanical loading.
