Femtosecond-laser-induced damage initiation mechanism on metal multilayer dielectric gratings for pulse compression

Haopeng Huang^{a, b}, Fanyu Kong^a, Zhilin Xia^c, Yunxia Jin^{a, *}, Linxin Li^{a, b}, Leilei Wang^{a, b}, Junming Chen^{a, b}, Yun Cui^a, Jianda Shao^a

The femtosecond-laser-induced damage behaviors of metal multilayer dielectric gratings (MMDG) for pulse compression are explored. The grating ridge of this type of MMDG consists of a layer of HfO₂ sandwiched between two SiO₂ layers. The initial damage position is on the HfO₂ layer of the ridge which opposite to the laser beam direction. A theoretical model is constructed to explain the femtosecond-laser-induced damage initiation mechanism on the MMDG, and the model can simulate the evolution of the electron density in the conduction band and the change of the dielectric constants of HfO₂ and SiO₂ in the sandwiched grating structure. The dramatic increase in the imaginary part of the dielectric constant of the middle HfO₂ layer indicates that it strongly absorbs laser energy, resulting in damage to the MMDG. The experimental results and theoretical calculation agree very well with each other.

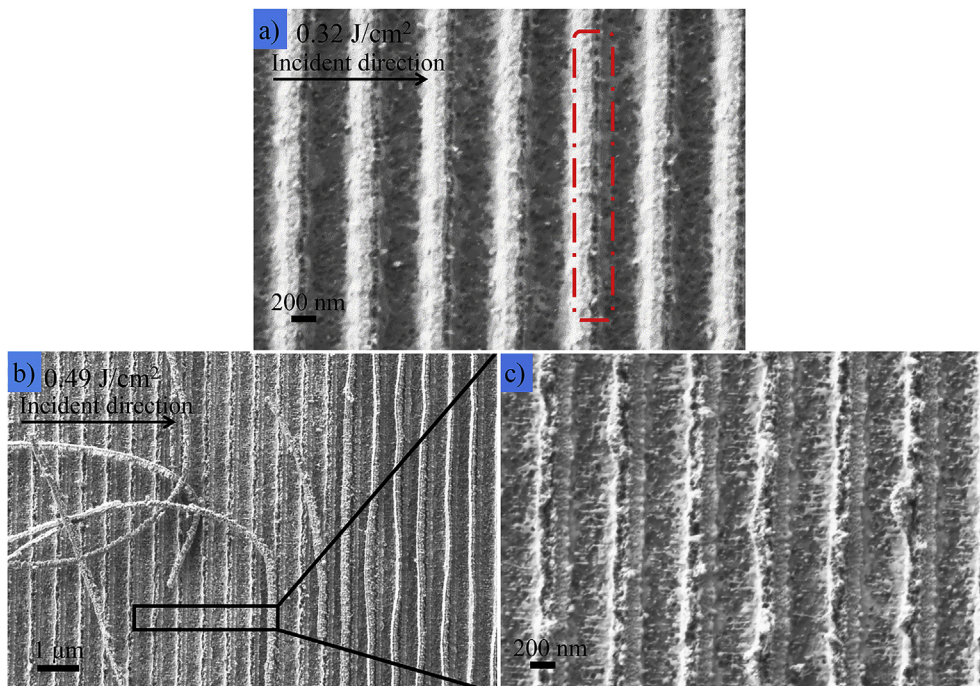
The fine morphologies are characterized by SEM and the damage morphologies with different laser fluences are shown in Fig. 2. The position which the MMDG is damaged is located on the grating ridges opposite to the incident wave (see the red dashed frame in Fig. 2(a)). The initial damaged positions are formed ablation lines in the pillars of the MMDG. The grating lines of the MMDG are gradually stripped as the fluence increases, finally resulting in catastrophic damage (see Fig. 2(b) and (c)).

Fig. 2. SEM images of typical damage morphologies. (a) Damage morphology at a fluence of 0.32 J/cm² near the damage threshold. (b) Typical damage morphology at a higher fluence of 0.49 J/cm². The pillars of the MMDGs are stripped. (c) Local magnification of (b).
