Damage of physical vapor deposition coatings of cutting tools during alloy 718 turning

Shuho Koseki^{a,*}, Kenichi Inoue^b, Hiroshi Usuki^c

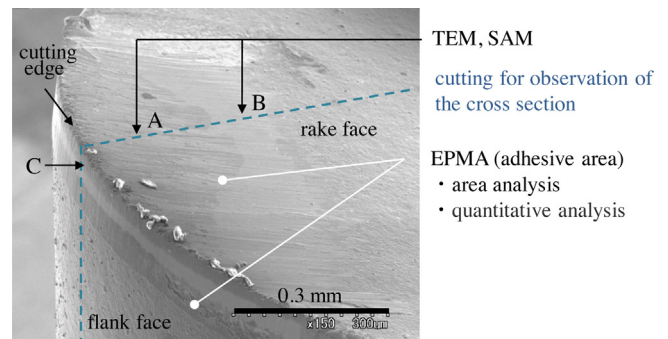
Fig. 1. Analysis point of the cutting tool after turning alloy 718.

Fig. 1 shows the SEM image of the tool edge after machining and the positions where various analyses were performed.
