Damage assessment and refurbishment of steam turbine blade/rotor attachment holes

D.G. Hattingh^{a,*}, M.N. James^{a,b,*}, M. Newby^c, R. Scheepers^c, P. Doubell^c

^c Eskom Holdings SOC Ltd, Rosherville Johannesburg, South Africa

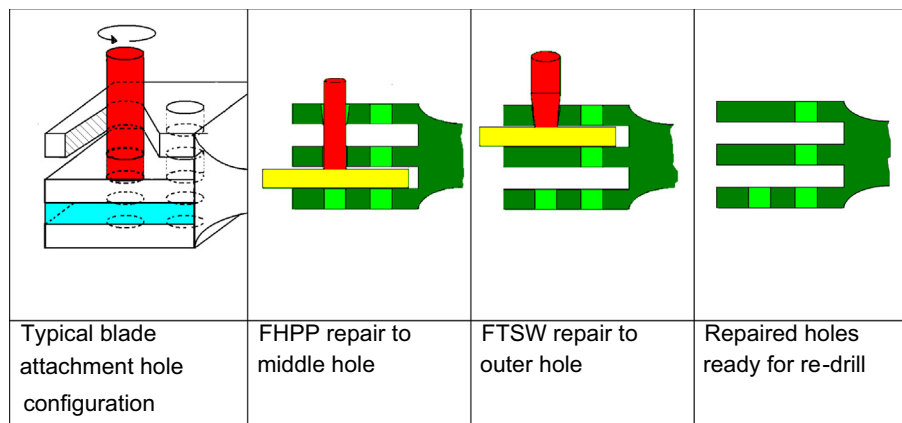
Fig. 1. Schematic illustrating the repair of finger blade attachment points by FHPP.

In the case study presented here the decision was made to repair the attachment holes and Fig. 2 shows the type of defects which can be repaired by welding and that are well suited to use of the friction hydro-pillar processing (FHPP) technique.
