# Fractographic analysis of a dental zirconia framework: A case study on design issues

Fractographic analysis of clinically failed dental ceramics can provide insights as to the failure origin and related mechanisms. One anterior 6-unit all-ceramic zirconia fixed partial denture (FPD) (Cercon<sup>®</sup>) has been clinically recovered and examined using qualitative fractography. The purpose was to identify the fracture origin and to state the reasons for failure. The recovered parts of the zirconia FPD were microscopically examined to identify classic fractographic patterns such as arrest lines, hackle, twist hackle and wake hackle. The direction of crack propagation was mapped and interpreted back to the origin of failure at the interface of the occlusal-palatal tip of the core and the veneering ceramic. An inappropriate core drop design favoring localized stress concentration combined with a pore cluster in the veneering ceramic at the core tip interface were the reasons for this premature through-the-core thickness failure.

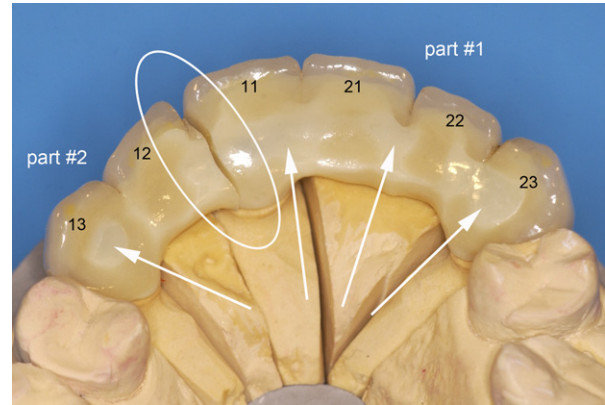
**Fig. 1 – Cercon® veneered six-unit anterior zirconia bridge, fractured between the upper teeth #11 and #12 in the maxillary arch (FDI numbers for each relevant tooth are labelled). The fracture surface distal of tooth #11 is labelled part #1, the fracture surface mesial of tooth #12 is labelled part #2. The region of fracture and exposed zirconia core structure are indicated by the circle and arrows. (For interpretation of the references to colour in this figure legend, the reader is referred to the web version of this article.)**

Fig. 1 shows the global palatal overview of the Cercon® six-unit anterior zirconia bridge repositioned on the working stone model. The fracture is located at the connector level (white circle) between the central right incisor (tooth #11) and the pontic tooth #12. The two fractured parts analyzed have been labeled part #1 for the fractured surface view towards
