Special Issue PCF 2014

Welding assessment of a damaged crane pedestal of a container ship

M. Fonte^{a,b*}, M. Freitas^b, B. Li^b, P. Duarte^a, L. Reis^b

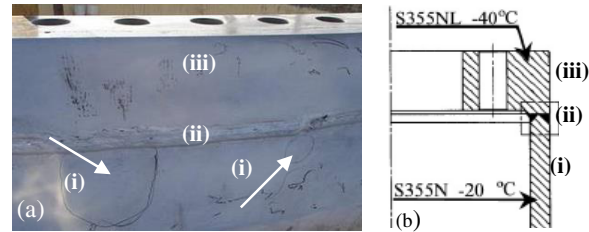
The pedestal/column is a hot rolled steel plate, see Fig. 2 (a) and (b). The material of flange (upper ring, iii) is steel S355NL (27 joules/-40 °C) (a), and the hot rolled steel plate is the S355N (27 joules/-20 °C), as can be seen in the sketch, Fig. 2 (b). The flange cross-section is 112 mm x 84 mm, and the hot rolled steel plate is 25 mm thickness.

Fig. 2. (a) Crane base pedestal/column surface where cracks were localized (i); (b) column sketch with the upper ring (iii), shell plate (i) and the weld seam (ii).

According to the shipyard report, surface cracks were found at inside and outside of the hot rolled steel plate (25 mm thickness), close to the main weld seam, as is shown in Fig. 2 (a) (i), and some ones also appeared on the welding seam. Most of cracks were found to starboard of the crane. The cracks size ranged between 50 mm and 100 mm long and between 1 mm and 5 mm deep. Cracks were detected by NDT, i.e. magnetic particles and ultra-sounds test. As the cracks size were considered acceptable by the shipyard, the technical services for ship repairs removed them by grinding of the material as it is shown in Fig. 3 (a) and (b) indicated with white arrows.

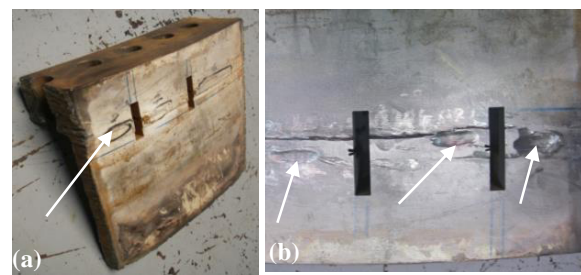
Fig. 3. (a) Flange and (b) hot rolled steel plate, with two holes from where the samples were cut.
