# Behavior of an adhesive joint under weak-axis bending in a pultruded GFRP bridge deck

Sin-Zeon Park, Kee-Jeung Hong\*, Sung-Woo Lee

School of Civil and Environmental Engineering, Kookmin University, 77 Jeongneung-ro, Seongbuk-gu, Seoul, Republic of Korea

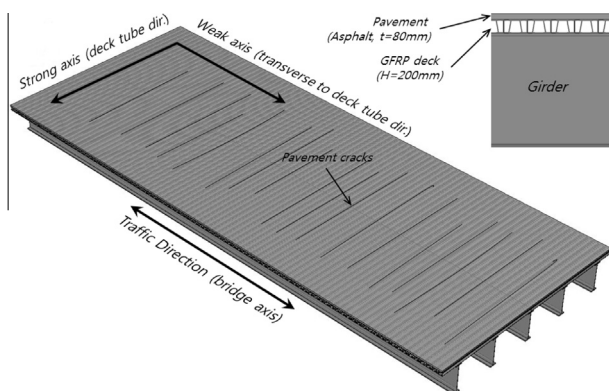
Fig. 1.1. Pavement cracks and strong and weak axes of a pultruded GFRP deck.

2004. The reflective cracks in the asphalt pavement occur mainly along the adhesive joints perpendicular to the bridge axis, as shown in Fig. 1.1. From this image, we can assume that the local behavior of the adhesive joints under weak-axis bending, rather than environmental factors, is likely the cause of the reflective cracks. To prevent these cracks, the local behavior of adhesive joints under weak-axis bending should be identified.

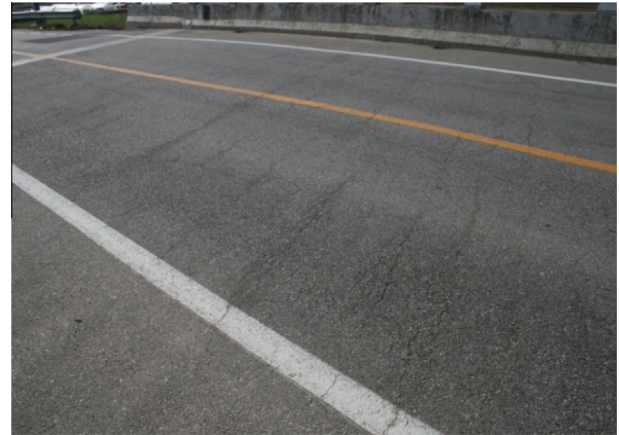
To build a pultruded GFRP bridge deck system, deck tubes should be connected to each other by adhesive bonding at the joints. These adhesive joints locally form flexible and weak regions due to the relatively low elastic modulus and low tensile strength of a typical adhesive, thus influencing the behaviors of the GFRP decks in weak-axis bending. Concentrated deformation at these flexible and weak regions under weak-axis bending also causes reflective local cracks on the asphalt pavement of an in-use GFRP bridge deck. Fig. 1.1 shows reflective local cracks on the pavement of a pultruded GFRP deck in a typical steel-plate-girder bridge. The figure also indicates the strong- and weak-axis of the pultruded GFRP deck. Fig. 1.2 shows a picture of reflective cracks on 80 mm-thick asphalt pavement on an in-use GFRP deck of an actual steel-plate-girder bridge, the Gae-Jung Bridge, built in

Fig. 1.2. Pavement cracks of an in-use GFRP deck (Gae-Jung Bridge).
