Technical Report

Cement kiln dust induced corrosion fatigue damage of gas turbine compressor blades – A failure analysis

M.R. Jahangiri^{a,*}, A.A. Fallah^a, A. Ghiasipour^b^a Metallurgy Department, Niroo Research Institute, Tehran 14686, Iran^b Rey Power Plant, Rey City, Iran

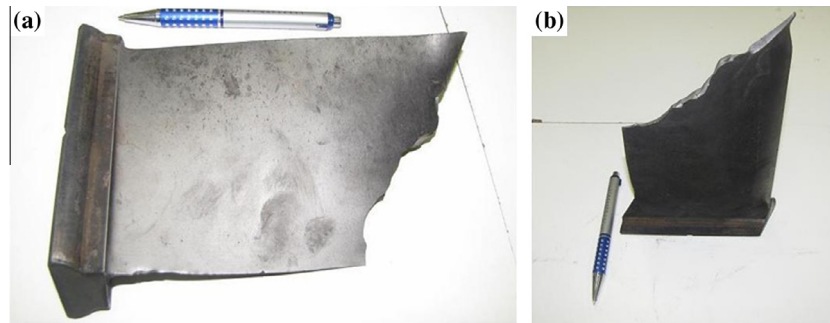
Fig. 1. (a and b) Images of the broken blades from different views.

The first stage stationary blades (vanes) had not suffered significant damage. This can be a sign that the surge phenomenon has not been occurred [8,9]. The first stage rotating blades were suffered more damage, and some of them were completely broken in the middle. Bottom section of a broken blade was studied in this study (Fig. 1).

As can be seen in Fig. 1, the fracture surface makes an angle of 45° with respect to the longitudinal blade axis. There was a black greasy deposit on the surfaces of the blade. After cleaning the blade surfaces, small traces of erosion were observed on the blade leading edge.

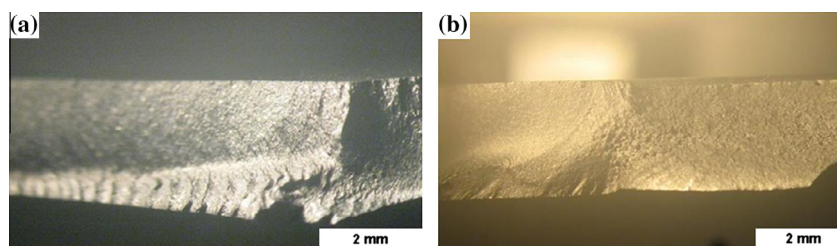
Fig. 2. (a and b) Stereo microscopy images of different regions of the broken blade fracture surface.
