Premature failure analysis of forged cold back-up roll in a continuous tandem mill

In this paper, premature failure of a forged back-up roll from a continuous tandem mill was investigated. Microstructural evolutions of the spalled specimen and surface of the roll were characterized by optical microscopy, X-ray diffraction, scanning electron microscopy and ferritscopy, while hardness value of the specimen was measured by Vickers hardness testing. The results revealed that the presence of pore and MnS inclusion with spherical and oval morphologies were the main contributing factors responsible for the poor life of the back-up roll. In addition, metal pick up and subsequently strip welding on the surface of the work roll were found as the major causes of failure in work roll which led to spalling occurrence in the back-up roll. Furthermore, relatively high percentage of retained austenite, say 9%, in outer surface of the back-up roll contributed spalling due to conversion of this meta-stable phase to martensite and creation of volume expansion on the outer surface through work hardening during mill campaign.

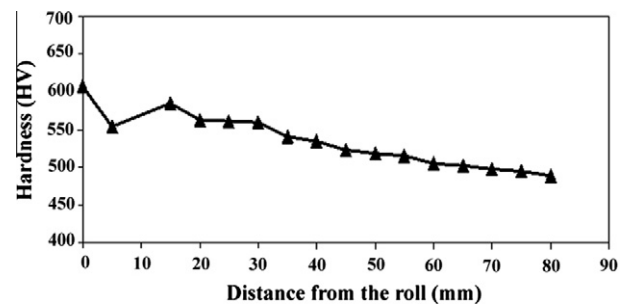
Fig. 2. Hardness profile of back-up roll.

Hardness profile, Fig. 2, was measured at every 5 mm distance from the working surface of back-up roll. As can be observed, hardness value of the samples decreased from 607 to 489 HV with increasing the distance from the working surface. However, there was a fluctuation in hardness value between 607 and 553 HV until the 17 mm distance from the surface of the back-up roll. The result revealed that the hardness value of the roll was almost close to the normal, whilst the main reason of fluctuated behavior in hardness profile may attributed to the softening some parts of working surface [3,4]. Fig. 3 shows the microstructure of the softening regions indicating a large amount of precipitated carbide caused by superficial tempering due to localized heating.
