Study on metallographic structure of melted breakpoint mark for copper wire current overloading

Abstract

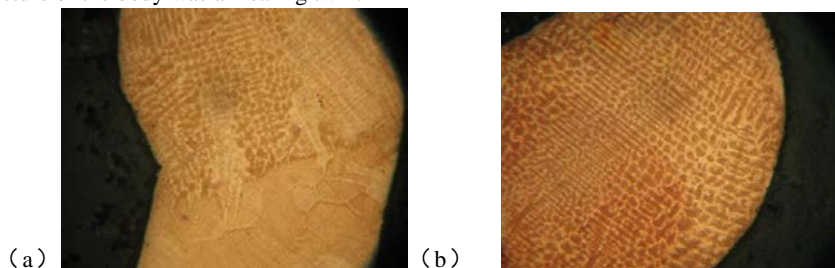
The metallographic structure of single-core wire melted breakpoint marks was shown in Fig.1. It was found that the breakpoint mark microstructure was different from the body's microstructure, with distinct borders. None of pores was found in the structure. The grain boundaries were shown clearly and thick. The microstructure of breakpoint was unidirectionally arranged dendrite, indicated by red arrows. There was obviously dendritic segregation in microstructure. The microstructure of the body was annealing twin.

Fig.1. The microstructure of (a) 1 single-core wire breakpoint marks sample (50 \times) and (b) 2 single-core wire breakpoint marks sample (50 \times)
