## Case report

## Tibial tray fracture in a modern prosthesis with retrieval analysis

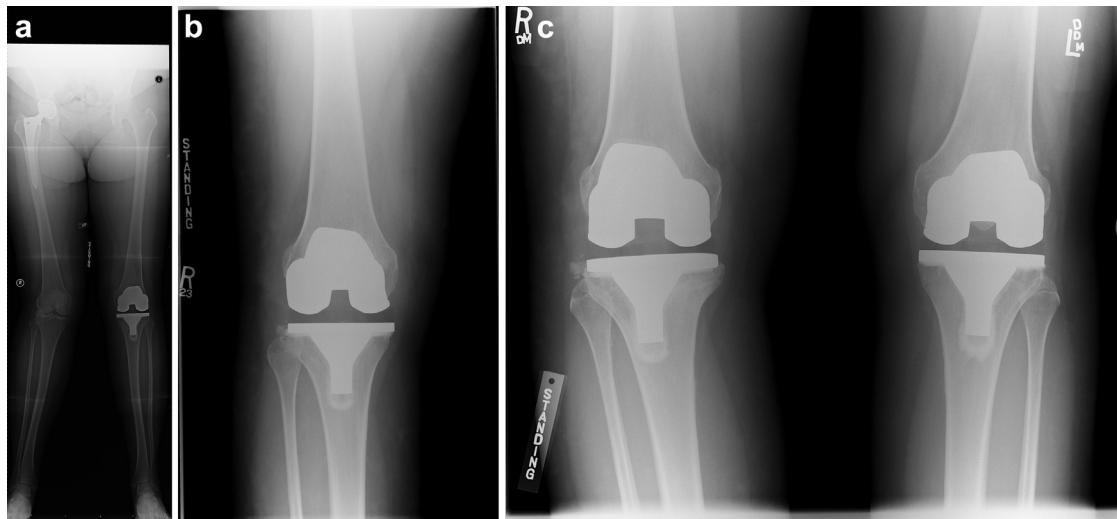
Examination of her knee revealed a fixed valgus deformity of approximately 15°–20° and a range of motion of 0°–110°. Radiographs demonstrated right knee osteoarthritis with valgus deformity (Fig. 1a). The patient failed conservative measures for her symptoms and elected to undergo right TKA in February 2009, utilizing a PFC Sigma design (DePuy, Warsaw, IN) with a polished, chrome cobalt tibial tray. The prosthesis was fixed with cement, and a 12.5-mm polyethylene insert was used. The procedure was uneventful. Postoperatively, the knee was in 5° valgus alignment and knee radiographs demonstrated a stable implant (Fig. 1b). The patient did well after surgery and obtained complete pain relief.

At 1-year follow-up, she complained of recent onset medial knee pain in the area of the pes anserine bursa. Radiographs were unremarkable (Fig. 1c). She was diagnosed with pes anserine

**Figure 1.** (a) Anteroposterior (AP) long leg preoperative radiographs from February 2009 (b) AP right knee at 6 weeks postoperative (c) AP bilateral knees at 1 year postoperative (d) AP and lateral radiographs first demonstrating tibial tray fracture in July 2010 (e) AP long leg radiographs 1 month after revision procedure (f) AP bilateral knees at 5 years after revision procedure.

bursitis and received a short course of oral corticosteroids. She returned 3 months later without improvement in her symptoms and she underwent a corticosteroid injection into the pes anserine bursa. The injection provided partial relief, but she returned 1 month later with progressive symptoms. At this time, the right knee was found to be in 15° varus. Radiographs were obtained and demonstrated a fracture of the tibial tray (Fig. 1d).

The patient underwent revision of the tibial component in July 2010. At the time of surgery, there was necrotic bone within the posteromedial aspect of the tibial plateau. High-speed burrs were used to debride the necrotic bone to healthy bleeding bone. A DePuy PFC Sigma revision tibial component was inserted and fixed with cement. No augments were needed, and the alignment of the knee was corrected. The patient tolerated the procedure well without complications (Fig. 1e). Intraoperative cultures and cell counts did not provide evidence of any underlying infection. She returned to full activity postoperatively and was asymptomatic at her most recent follow-up, 5 years later (Fig. 1f).
