Arthroplasty Today

Case report

Fracture of the femoral adapter bolt and taper adapter in a modern rotating platform knee arthroplasty

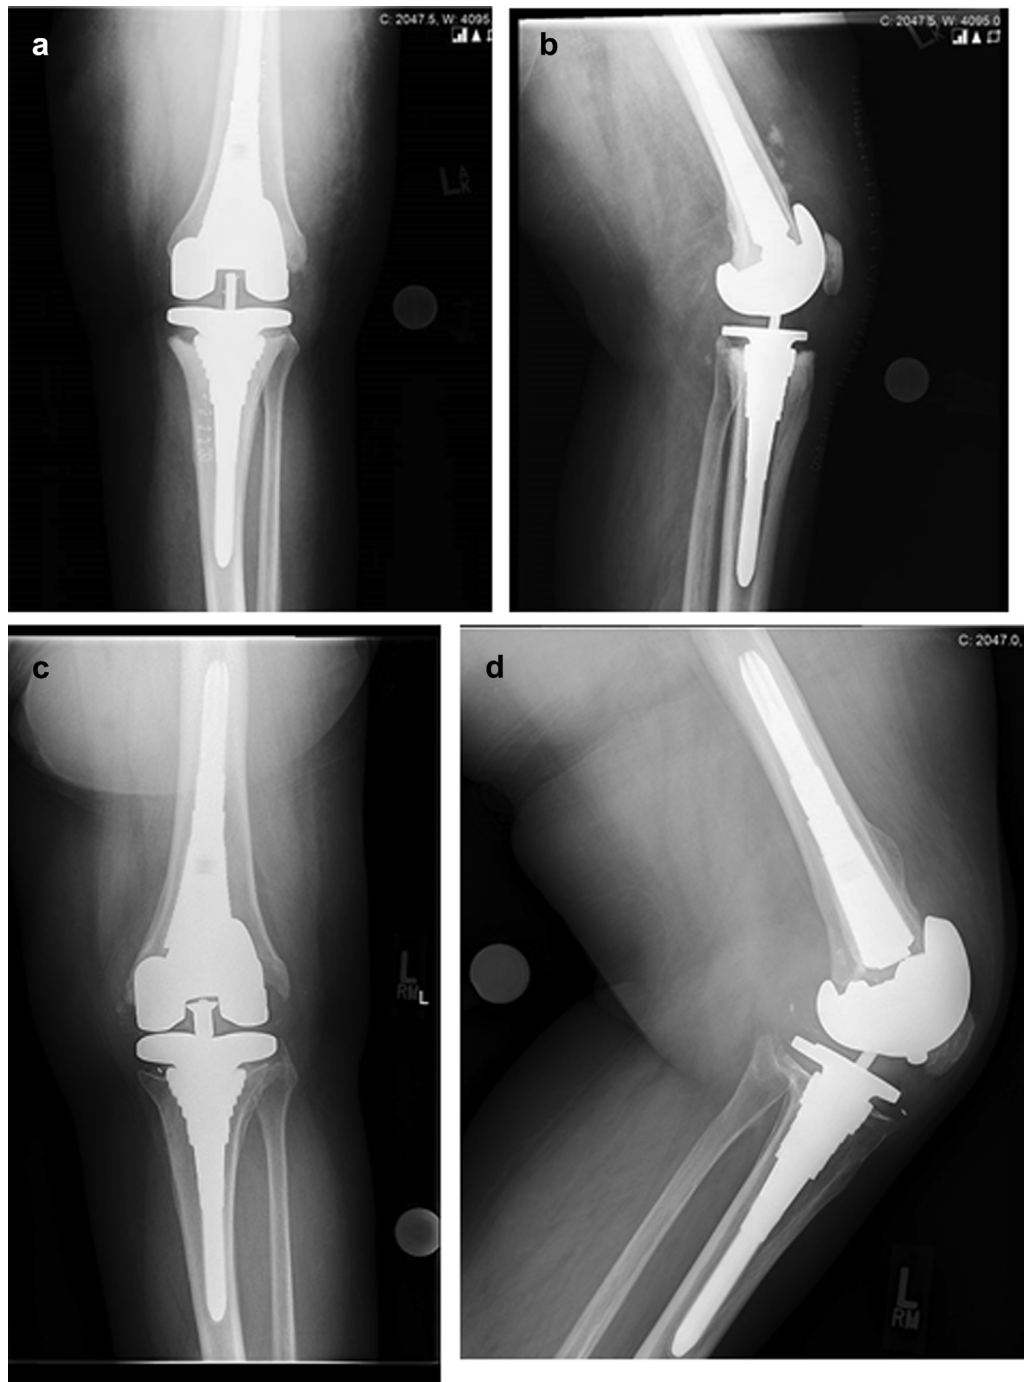
Figure 1. Anteroposterior (AP) (a) and lateral (b) radiographs obtained at revision surgery in 2010. 4.5 years later, the patient presented with onset of pain and AP (c) and lateral (d) views confirmed fracture of the implant and taper disengagement from the metaphyseal stem.

In November of 2014, 4.5 years after her revision TKA surgery, the patient presented after twisting her knee. At the time of the twisting injury, she experienced an accompanying sudden popping
