Arthroplasty Today

Case report

Fatigue fracture of a cemented Omnifit CoCr femoral stem: implant and failure analysis

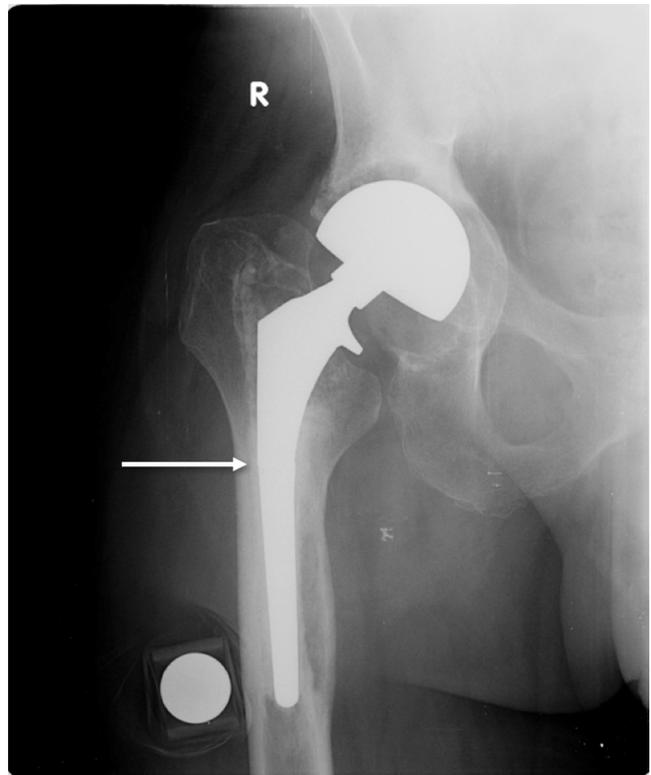
A 55-year-old male patient (height, 72 inches; weight, 230 lb; body mass index, 31.3) had a right hemiarthroplasty in 1990 to treat a femoral neck fracture. The implanted device was a cemented, collared, cast CoCr alloy, Omnifit Plus stem (size #6, 25-mm neck) coupled with a modular, skirted femoral head (26 mm, +10 mm neck extension) and a UHR Universal Head (53 mm). The femoral neck extension was employed presumably to avoid a leg-length discrepancy due to a low femoral neck resection resulting from femoral neck fracture. After 24 years, the patient presented with progressive right hip pain to the point of requiring crutches for ambulation. Physical examination demonstrated weak abduction and flexion muscle activity, and pain associated with straight leg raises, passive flexion, and external and internal rotation. Radiographs (Fig. 1) revealed a mid-stem fracture, acetabular osteolysis, proximal implant migration, and a loose cement mantle. The femoral head appeared to be eccentrically positioned slightly above the center of the outer bipolar component. Additionally, a protrusion acetabular deformity was noted, as was a cortical hypertrophy in the medial mid-femoral diaphysis (Fig. 1).

Figure 1. Radiograph of the primary implant reveal a mid-stem fracture, acetabular osteolysis, proximal implant migration, and a loose cement mantle. The location of fracture is denoted by the white arrow.

The patient was scheduled for revision surgery in November of 2014 to remove the failed components and convert the hemiarthroplasty to a total hip arthroplasty. During revision surgery, the distal aspect of the broken stem was found to be well fixed and required an extended trochanteric osteotomy for removal. At the most recent follow-up (approximately 12 months), the patient has shown recovery from the revision surgery, demonstrating acceptable range of motion, return to activities of daily living, and markedly decreased pain.

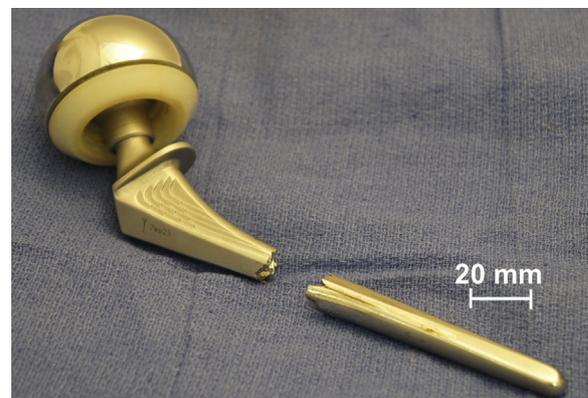
Optical inspection of the implant revealed failure at the mid-portion of the stem, at approximately 38% of the stem length, measured from the collar (Fig. 2). Low-magnification photographs (Fig. 3) show a large apparent grain structure at the location of fracture.

Figure 2. Photograph showing failure at the midportion of the stem, at approximately 38% of the stem length, measured from the collar.
