Case report

Occupant accelerations and injury potential during an ambulance-to-curb impact

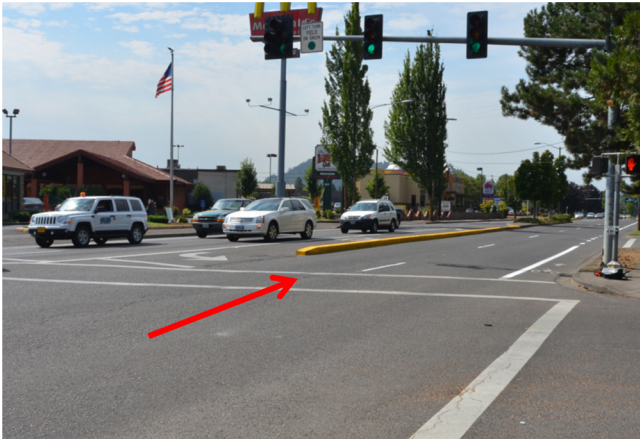
Fig. 1. The ambulance was traveling southbound, straight through an intersection (direction of red arrow). The tire(s) of the ambulance mounted the center concrete median.

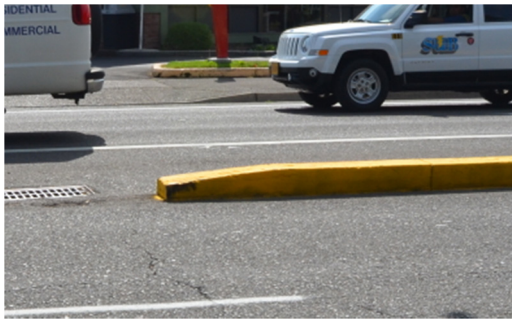
Fig. 2. Concrete median/curb struck by the 2009 International ambulance. The initial height is 10 cm and the full height is 19 cm.

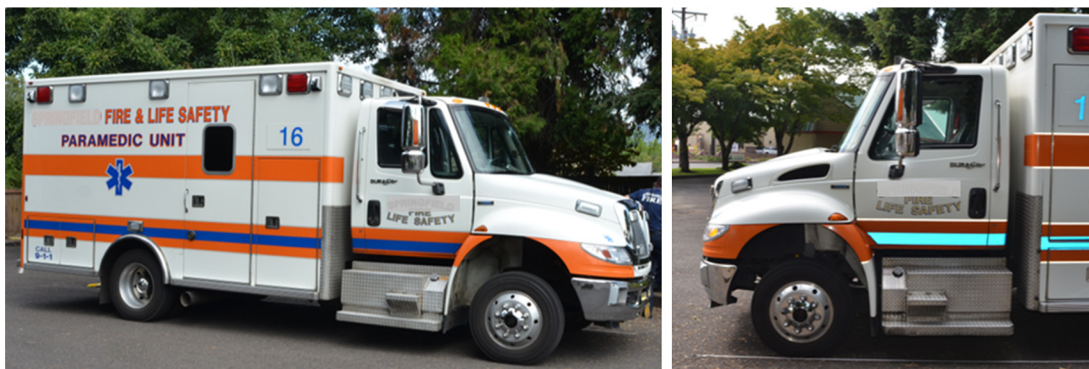
Fig. 3. There was no damage to the front left wheel, tire or undercarriage of the 2009 International ambulance following impact with the center median.
