# Testing of HSH<sup>®</sup> rails in high-speed tracks to minimise rail damage

### 3. Track test of HSH<sup>®</sup> rails in the network of DB AG

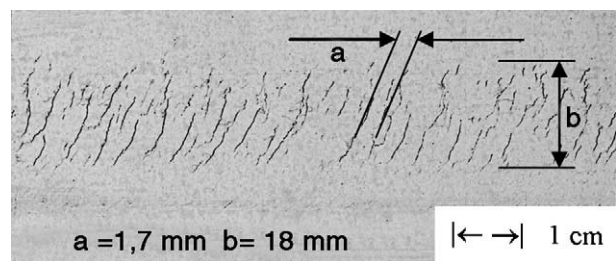
Fig. 1. MPI graph of the rail head surface, grade 800.

After 3 years of service life corresponding to a total load of 90 MGTs, all three rail grades showed head checks very clearly, but in a different formation (Figs. 1–3). The foot line of the pictures represents the gauge corner, the upper line the middle of the rail. The head checks appeared not as mostly
