## International Journal of Surgery Case Reports

## Catastrophic metallosis after tumoral knee prosthesis failure: A case report

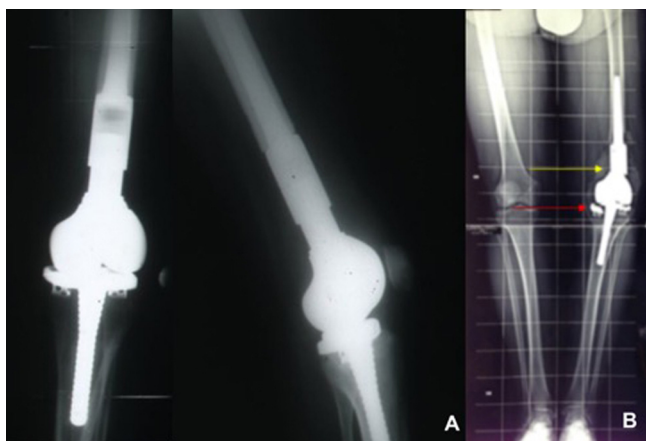
At CT-scans the lung were free from metastasis. No perioperative complications were reported; the patient was followed until the 5th year after surgery. At the last follow-up there were no local recurrence of the oncologic disease and the prosthesis showed no signs of mobilization (Fig. 1A). In November 2010 the patient reported a car accident, with a direct trauma to the left lower limb. The X-ray showed a two-point prosthesis breakage (femur and medial tibial plateau) and a femoral stem subsidence (Fig. 1B). However, he was able to walk independently and with moderate pain. Despite surgeon advice, the patient refused revision surgery for personal reasons. In December 2012, the patient returned to the outpatient clinic, with an increasing pain in his left knee and with lower limb length discrepancy. The clinical examination revealed a massive black dyspigmentation of the skin (Fig. 2C), moderate swelling, mild warmth and tenderness. Clinical assessment revealed the left (surgical) leg was 2 cm shorter than the right. The range of motion was 5°–35°, severely decreased compared to previous examinations. Plain X-rays (Fig. 2A–B), that confirmed the lower limb discrepancy, were suspicious for metallosis: presence of radio-dense line ("cloudy sign"), associated with "the bubble sign" described by Su [2] and the "metal-line sign" a thin rim of linear increased density in the suprapatellar pouch region described by Weissman [3].

**Fig. 1.** (A) Radiographs taken at 5-year follow-up (year 2000) showing a cementless Kotz modular femoral and tibial reconstruction (KMFTR) in an acceptable positioning. (B) An anteroposterior standing radiograph of the lower left limb showing fracturing of the proximal femoral stem (yellow arrow) and medial tibial plateau (red arrow).

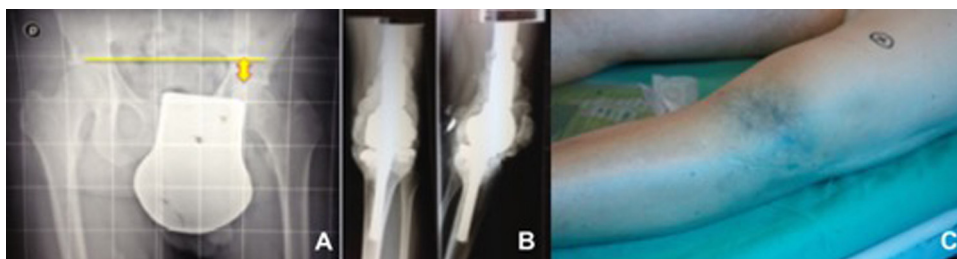
**Fig. 2.** (A) Patient presented a large area of cutaneous metallosis characterized by dyspigmentation of the skin overlying the joint space affected. (B) anteroposterior standing radiograph demonstrating dismetry: left (surgical) leg was 2 cm shorter than the right with a deviation in varus of the knee. (C) A-P and L-L X-rays showing the typical amorphous, increased density material defined as “cloud sign” of metallosis.

The laboratory investigations showed leukocyte count = 9600 cell per cubic millimeter, C-reactive protein = 78 mg/L, and erythrocyte sedimentation rate = 46 mm/h. The patient accepted surgery and was scheduled for revision of his TKP. In January 2012, the patient was operated in supine position without the use of

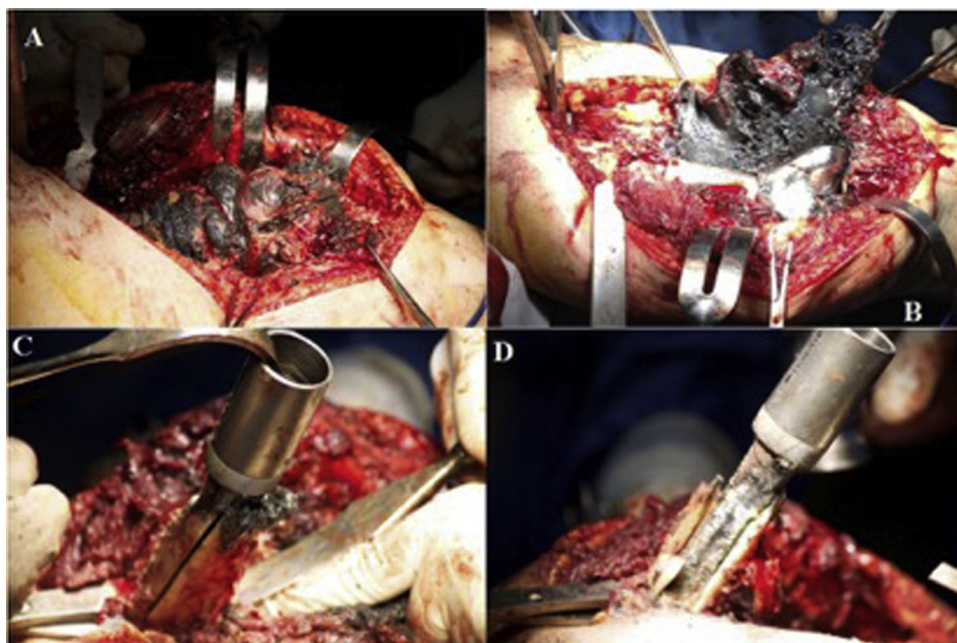
massive soft tissue metallosis of the distal femur and the proximal tibia (Fig. 3A–B). However, there was not osteolysis, both prosthetic stems resulted still well bone-integrated (Fig. 3C–D). The revision surgery was not more difficult than any others revision procedure. It was more difficult to identify anatomic structures due to soft tissue pigmentation. After prosthesis components removal, both femoral and medial tibial plateau fracture were confirmed and an extensive polyethylene wear and deformation distributed asymmetrically over the medial and lateral joint surfaces was detected (Fig. 4).

**Fig. 3.** Intraoperative photographs show (A–B) massive metallosis of the soft tissue adjacent to the prostheses, and (C–D) absence of osteolytic reaction with the femoral prosthetic stem well integrated to bone.

tourniquet. The TKP was approached through a modified midvastus approach, extended proximally to the femur to allow a soft tissue debridement. Revision knee surgery confirmed the presence of
