Journal of Power Sources 258 (2014) 382-390

Failure analysis of electrolyte-supported solid oxide fuel cells

Felix Fleischhauer^{a,b,*}, Andreas Tiefenauer^c, Thomas Graule^a, Robert Danzer^b, Andreas Mai^d, Jakob Kuebler^a

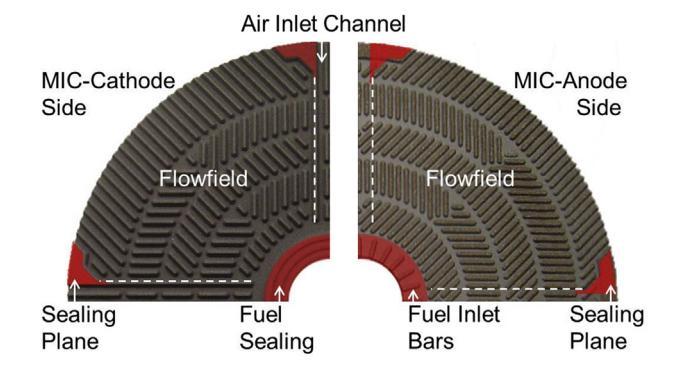
The fracture pattern consists predominantly of radial cracks which can be accompanied by secondary fracture around the central hole, as seen in Fig. 3. Less often occurred cracks with a

Fig. 2. Cathode side (left) and anode side (right) MIC structure with the positions of the air inlet channels and the flow-fields. The areas where frequent cell fracture is initiated are marked red. (For interpretation of the references to colour in this figure legend, the reader is referred to the web version of this article.)
