Engineering Failure Analysis

On the damage mechanisms in a continuous casting mold: Afterservice material characterization and finite element simulation

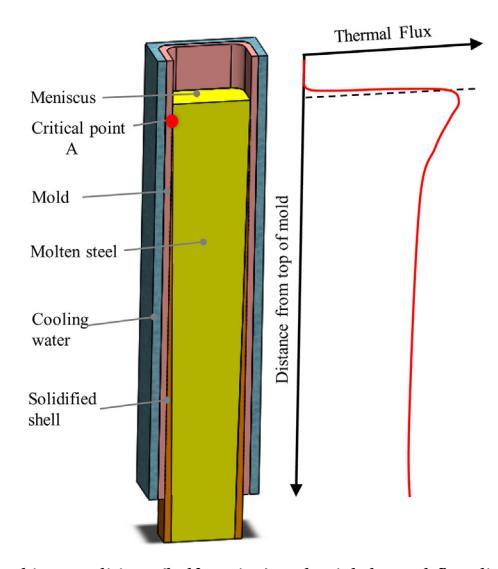
When the casting plant is operating, a huge thermal flux q is transferred from the molten steel, which is in contact with the inner mold surface, to the water-cooled outer side of the mold (Fig. 1). The values of this flux vary between two conditions: q = 0 when the plant is switched off, $q = q_{max}$ when the plant is switched on and has reached full capacity, (Fig. 2). The mold is exposed, on its inner surface, to a high time-varying temperature combined with a high thermal gradient across the mold wall. This cyclic thermal loading promotes thermal fatigue cracks in the meniscus area, which is the most thermally-stressed and strained region of the mold.

Fig. 1. A mold under working conditions (half section) and axial thermal flux distribution when $q = q_{max}$.
