# Petrographic identification of alkali–silica reactive aggregates in concrete from 20th century bridges

#### Šárka Lukschová \*, Richard Přikryl, Zdeněk Pertold

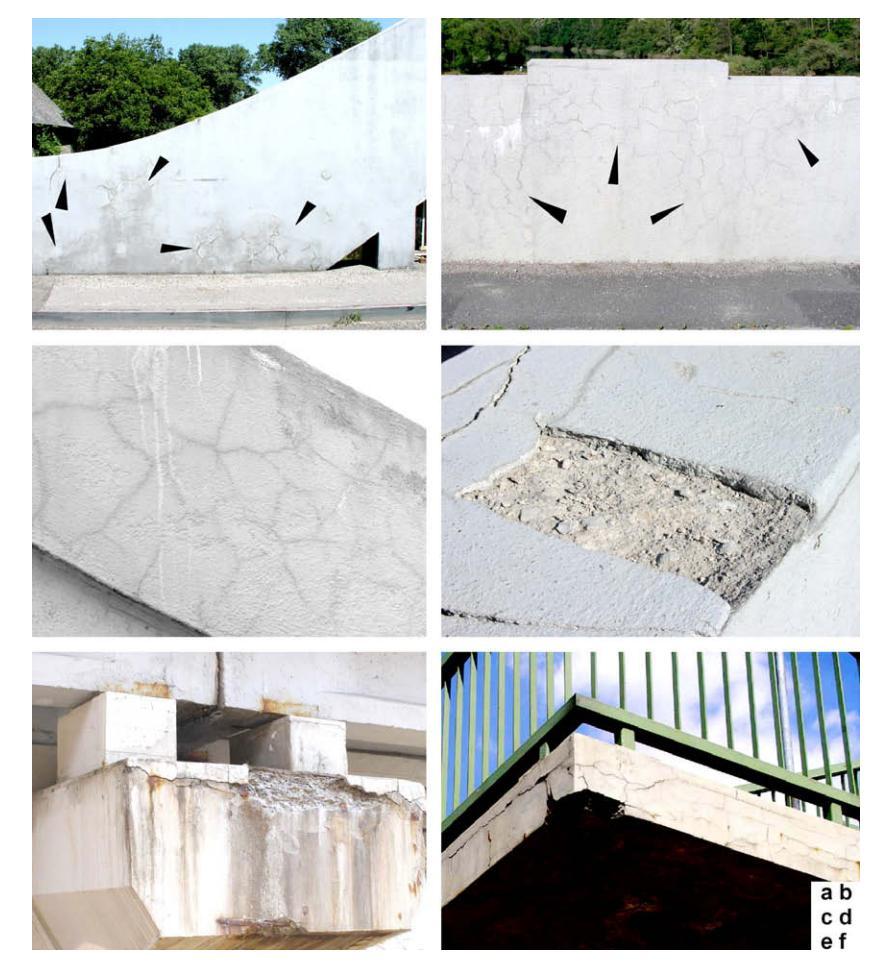
The concrete samples were taken from eight concrete bridges located at various places in the Czech Republic. The road bridges were constructed in the 1924–1982 period and have been considered to be "safe" from the point of view of ASR for a number of years or decades. During inspection in the 1990s, extensive signs of ASR were, however, identified on these structures and repair followed in the late 1990s. About five years after the repair work (in 2005), control samples were taken from the most damaged parts in order to evaluate the quality of the repair work and to examine the remnants of previous ASR. Visual examination of the damage ratio was carried out macroscopically "in situ" (according to the Czech National Standard ČSN 736221, [27]) by Pontex Ltd. All the bridges exhibit functionless protective coatings and large surface parts damaged by cracks (see Fig. 1). More detailed descriptions of the identified damage are given in Table 1.

Fig. 1. In situ observation of ASR. (a), (b) cracks through the face-side (indicated by black arrows), (c) detailed view of the net of cracks, (d) detailed view of the spandrel panel over the pillar, (e) front of the pillar damaged by concrete spalling, (f) cracks through the landing front.
