Soils and Foundations 2014;54(4):588-607

Damage to agricultural facilities

Yoshiyuki Mohri*, Susumu Masukawa, Toshikazu Hori, Mitsuru Ariyoshi

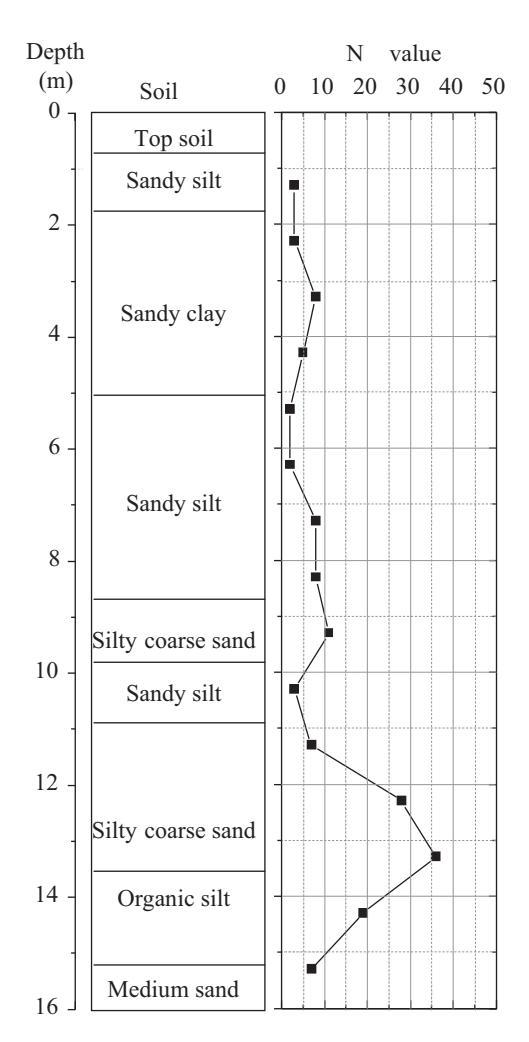
The Kumado river region is located in the west part of Sukagawa City in Fukushima Prefecture, as shown in Figs. 1 and 4. A large-diameter pipeline is installed underground, as roughly shown in Fig. 2, in soil comprised of sandy silt with an N value (Standard Penetration Test, SPT) of 10 or less at a depth of about 10 m below the ground surface, and coarse/ medium sand with an N value of more than 20 at a depth of about 10 m and deeper. In the hilly and mountainous areas, the ground at the installation depth of the pipeline consists of mainly silt and clay with an N value of 5–10.

Fig. 2. Result from boring survey conducted before earthquake at Kumado region in Fukushima Pref. (at Ooikenishi Conbined Junction in Fig. 4).

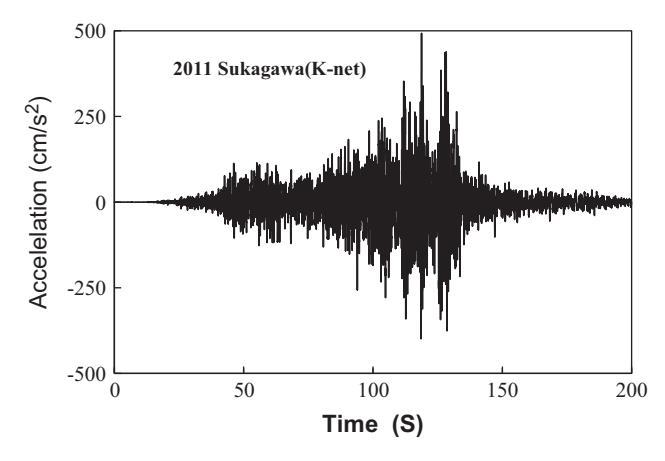
Data on the earthquake ground motions of the 2011 off the Pacific Coast of Tohoku Earthquake is shown in Fig. 3: EW acceleration at the K-Net Sukagawa site(FKS017) recorded at Sukagawa City in Fukushima Prefecture. The maximum acceleration of the EW motion was 492.9 cm/s^2 . The duration of this motion at the Sukagawa site over 50 cm/s^2 continued for 100 s despite being more than 200 km from the epicenter, which was an earthquake motion never which had been experienced. The distribution of the duration of acceleration over 50 cm/s^2 was located from the Tohoku region to Kanto region (Sasaki et al., 2012). The duration times in the Tohoku

Fig. 3. Accelelation records at Sukagawa (K-net).
