A Strange Case of Downward Displacement of a Deep Brain Stimulation Electrode 10 Years Following Implantation: The Gliding Movement of Snakes Theory

Citation: *World Neurosurg.* (2015) 84, 2:591.e1-591.e5.

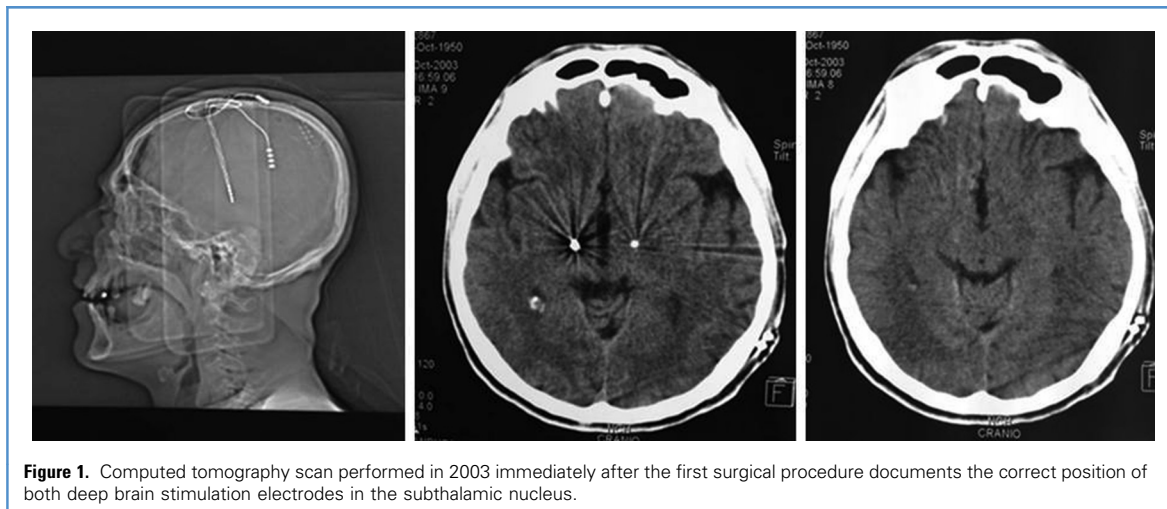
A 53-year-old man with a 16-year history of Parkinson disease was evaluated for DBS implantation. His tremor, bradykinesia, and postural instability worsened despite maximal medical therapy, and he developed on-off fluctuations, off-state freezing, and severe on-state dyskinesias. He underwent bilateral microelectrode-guided placement of DBS electrodes into the subthalamic nucleus (STN) according to our standard protocol (6, 7). The DBS electrodes were fixed to the skull by a silicone burr hole ring and cap supplied by the manufacturer of the DBS equipment (Medtronic Inc., Minneapolis, Minnesota, USA). The excess length of electrode was coiled under the scalp. A postoperative computed tomography (CT) scan showed that the electrodes were appropriately placed in the STN region and that there had been no intraparenchymal hemorrhage (Figure 1). A 2-channel pulse

Figure 1. Computed tomography scan performed in 2003 immediately after the first surgical procedure documents the correct position of both deep brain stimulation electrodes in the subthalamic nucleus.

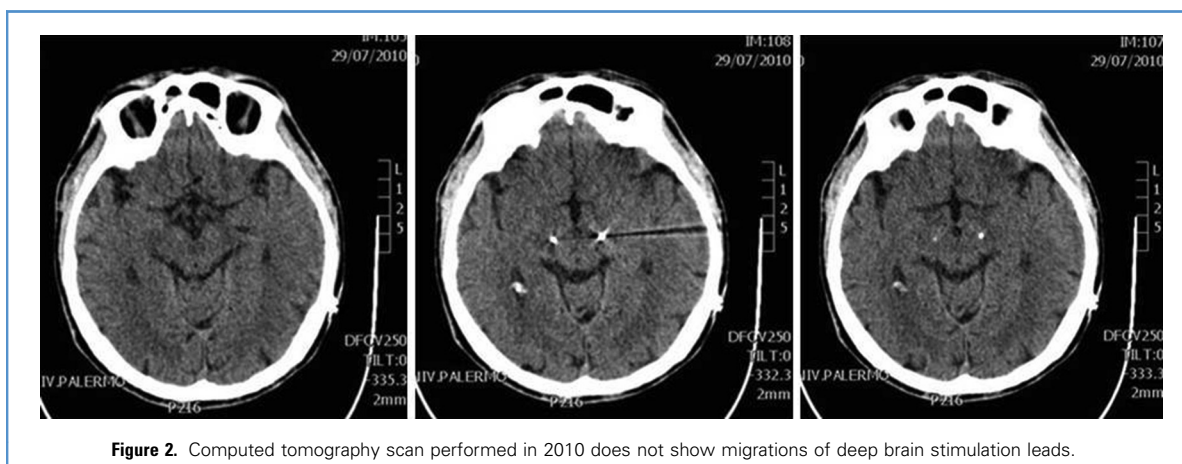
After implantation and activation of the DBS 2 weeks later, the patient's motor scores on the Unified Parkinson's Disease Rating Scale significantly improved from 54 to 43, and his medication doses could be gradually reduced. Both distal contacts were activated (contacts 0 and 4 negative; case positive), and parameters of voltage, width, and frequency were 2.5 V, 60 μ , and 130 MHz. The left generator became depleted 7 years later and was replaced. A new CT scan was obtained that confirmed the position of both leads at the original site (Figure 2).

Figure 2. Computed tomography scan performed in 2010 does not show migrations of deep brain stimulation leads.
