Case report

An unusual presentation of catastrophic failure of hip arthroplasty with a thigh mass

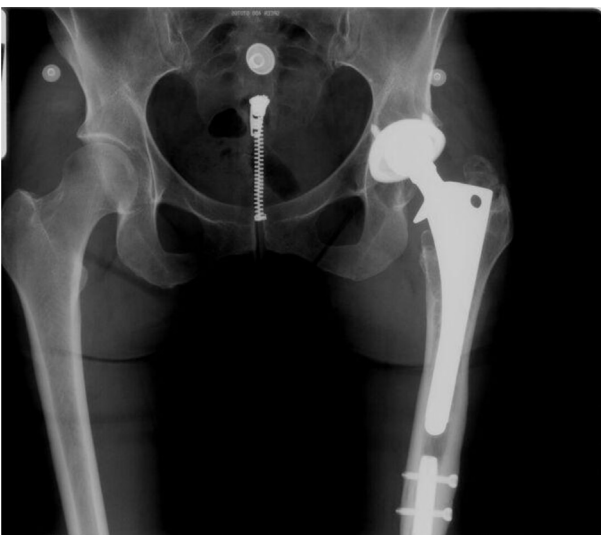
Figure 2. Anteroposterior radiograph of original left total hip arthroplasty with impending polyethylene wear-through (12 years from surgery).

Patient had excellent clinical results with her hip replacement, until she was seen in 2009 for left hip pain. Radiographs revealed polyethylene wear with impending wear-through; however, no surgical treatment was offered at that time (Fig. 2). She had no further follow-up until 2014, when she returned with a 3-month history of left hip pain and a progressively enlarging painful anterior thigh mass. She denied any infectious signs and symptoms. As a result of the pain, she was dependent on a walker for ambulation. Furthermore, she was unable to work and severely limited even with activities of daily living. Radiographs revealed left total hip prosthesis with complete wear-through of the femoral head through the polyethylene liner and the acetabular component (Fig. 3). Infectious workup resulted negative (normal C-reactive protein and estimated sedimentation rate). She underwent a computed tomography (CT)-guided hip aspiration. CT scan of the hip confirmed the acetabular protrusion of the femoral head and an anterior thigh fluid-filled mass (Fig. 4). Fluid aspiration was noted to be “dark/motor oil” in color and consistency. Samples from the hip joint and mass aspiration were negative for infectious etiology.

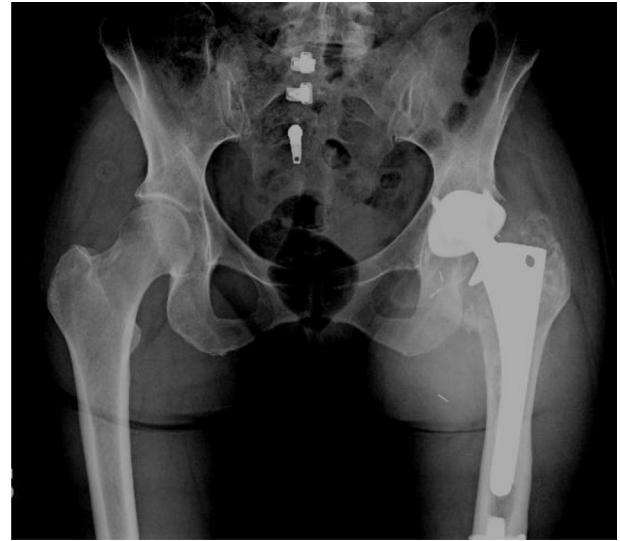
We present an unusual presentation of catastrophic failure of a total hip arthroplasty, with complete wear-through of the femoral head through the polyethylene liner and the acetabular socket with a large associated soft tissue thigh mass. Complete wear-through of

Figure 3. Anteroposterior radiograph of left total hip arthroplasty with complete wear of the polyethylene liner and the acetabular socket. The femoral head is mostly contained within the socket (17 years from surgery).

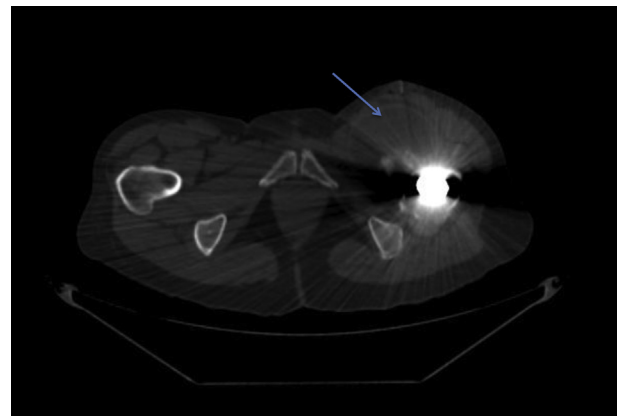
Figure 4. Axial computed tomography scan image demonstrating homogenous fluid collection in the anterior compartment of the left thigh (arrow).
