Electrode array misplacement into the superior semicircular canal: As a rare complication of cochlear implantation

Jia-Qiang Sun, Jing-Wu Sun^{*}, Xiao-Yan Hou, Yuan-Zhi Bie, Jian-Wen Chen

Department of Otolaryngology—Head and Neck Surgery, Anhui Provincial Hospital, Hefei 230001, Anhui Province, China

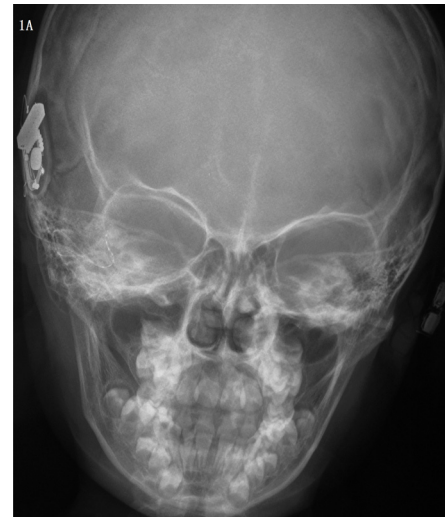
An 8-year-old male patient was implanted because of congenital profound-sensorineural deafness. The child was born term. Preoperative computed tomography (CT) and magnetic resonance imaging (MRI) showed that there was no malformations in inner ear. The patient underwent right cochlear implantation. Surgery was performed via posterior tympanotomy. After the round window niche was visualized, diamond burr (0.5 mm) was used to remove the round window niche overhang, maximally exposing the round window membrane. We found the round window membrane was smaller than usual. After placed the receiver stimulator the bony seat, the round window membrane was then carefully incised using a fine-curved pick, and a Med-El Combi 40+ electrode array (Medical Electronics Innsbruck, Austria) was carefully inserted through the round window membrane, resistance was not encountered while introducing the electrodes. The round window membrane was then closed with small pieces of temporalis fascia. Intra-operative neural response telemetry was not performed because of product C40+. X-ray in Stenver's view was performed second day after surgery. The result of X-ray showed doubtful abnormal placement of the cochlear implant electrode array (Fig. 1A).

Fig. 1. (A) X-ray in Stenver's view, showing the misplaced electrode entering probably the superior semicircular canal. (B) CT showing the misplaced electrode entering the superior semicircular canal.

The revision surgery with re-implantation were performed with extended round window insertion. The electrode array was removed and the round window was widened slightly antero-inferiorly. The electrode was inserted through extended round window, advanced within the scala tympani of the basal turn of the cochlea from its inferior segment to its ascending, superior and descending segments. Position of the electrodes was confirmed in the postoperative X-ray. The device was successfully programmed, and there has been considerable improvement in audiological and language performances after 1 year of follow-up.

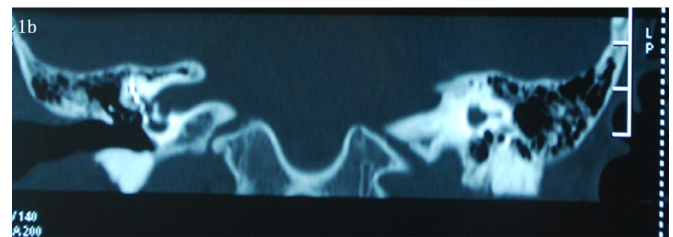
The child felt dizziness and no auditory perception upon the first electrical stimulation of the device. Electronic failure of the device was ruled out after performing various electrical tests that confirmed implant functionality. Postoperative CT indicated that the electrode array had been inserted in the superior semicircular canal (Fig. 1B).

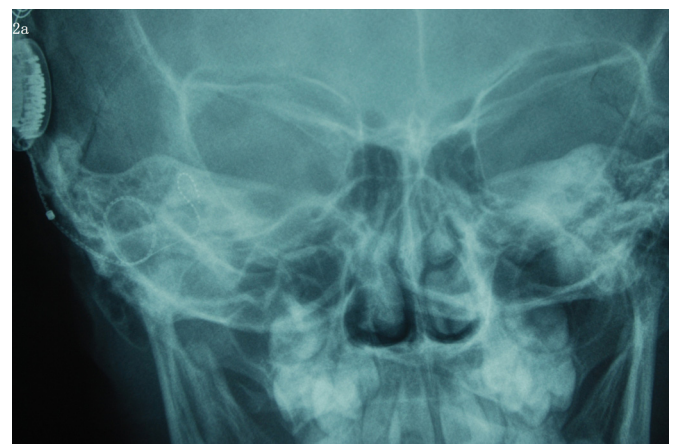
A 6-year-old female patient was implanted because of congenital profound-sensorineural deafness. The child was born term. Preoperative CT and MRI also showed that there was no malformations in the inner ear. We also found the round window membrane was smaller than usual. An Advanced Bionics Hires90k electrode array (Advanced Bionics, America) was carefully inserted through the round window membrane, resistance was not encountered while introducing the electrodes. Intra-operative neural response telemetry revealed absent responses. An X-ray in Stenver's view showed abnormal placement of the cochlear

Fig. 2. (A) X-ray in Stenver's view, showing the misplaced electrode entering probably the superior semicircular canal. (B) CT showing the misplaced electrode entering the superior semicircular canal.

The revision surgery with re-implantation was also performed with extended round window insertion. The electrode array was

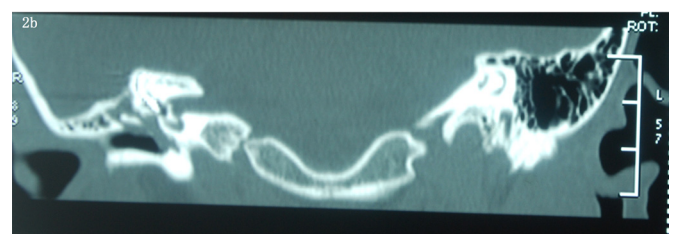
implant electrode array (Fig. 2A). Postoperative CT verified that the electrode array had been inserted in the superior semicircular canal (Fig. 2B).
