# Axillary lipogranuloma mimicking carcinoma metastasis after silicone breast implant rupture: A case report

A. Ozlem Gundeslioglu a,\*, Sibel Hakverdi b, Ozlem Erdem c, E. Cigdem Ozen a, Irfan Inan a, Dilek Emlik d

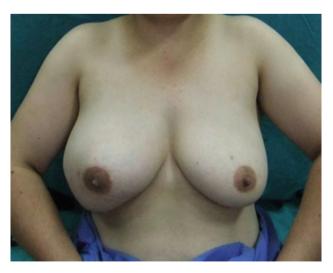
**Figure 1** Contour abnormality is seen on the right breast of the patient preoperatively.

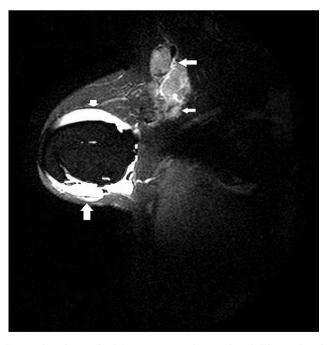
of silicone outside the implant lumen compatible with prosthesis rupture (Figure 2). She had no history of trauma related to breast implant rupture. She has been operated under general anaesthesia and on exploration, it was noted that the textured, round breast implant (without any label on it) had multiple tears with intracapsular silicone leakage. The implant was explanted with all leaked silicone and contracted capsule tissues around the implant were excised (Figure 3). The axillary mass was excised and sent histopathological examination. Histopathological examination revealed that the structure of all lymph nodes was disfigured. However, there was no sign of tumour or necrosis. Histopathology of the slides revealed numerous lipid vacuoles with surrounding inflammatory granulomatous infiltrate, involving epitheloid histiocyte proliferation and multinuclear giant cells. The proliferating histiocytes were positive for CD 68. The final histopathological diagnosis was lipogranuloma (Figure 4). The pathologic specimens were also evaluated by a polarised light microscope and it revealed that there were no refractive, birefringent silicone particles (Figure 5).

**Figure 2** Sagittal MR images were obtained with T2-weighted SPAIR sequence shows masses like lymphadenopathy at the superior aspect of the breasts (arrows) and collections of silicone outside implant lumen (arrowhead) which are diagnostic of extracapsular rupture.
